Whiteriver Unified School District, #20 Amendment #3		PO Box 190 959 S Chief Avenue Whiteriver, AZ 86303 (928) 358-5800
	IFB: 16-07-16 PROJECT: Roofing Project- Cradleboard Elementary School	Page 1 of 19

Cradleboard Elementary School
7301 Power Line Rd.
Whiteriver, AZ 85941

Project: Roof Assessment

Inspection Date: 7/12/2016

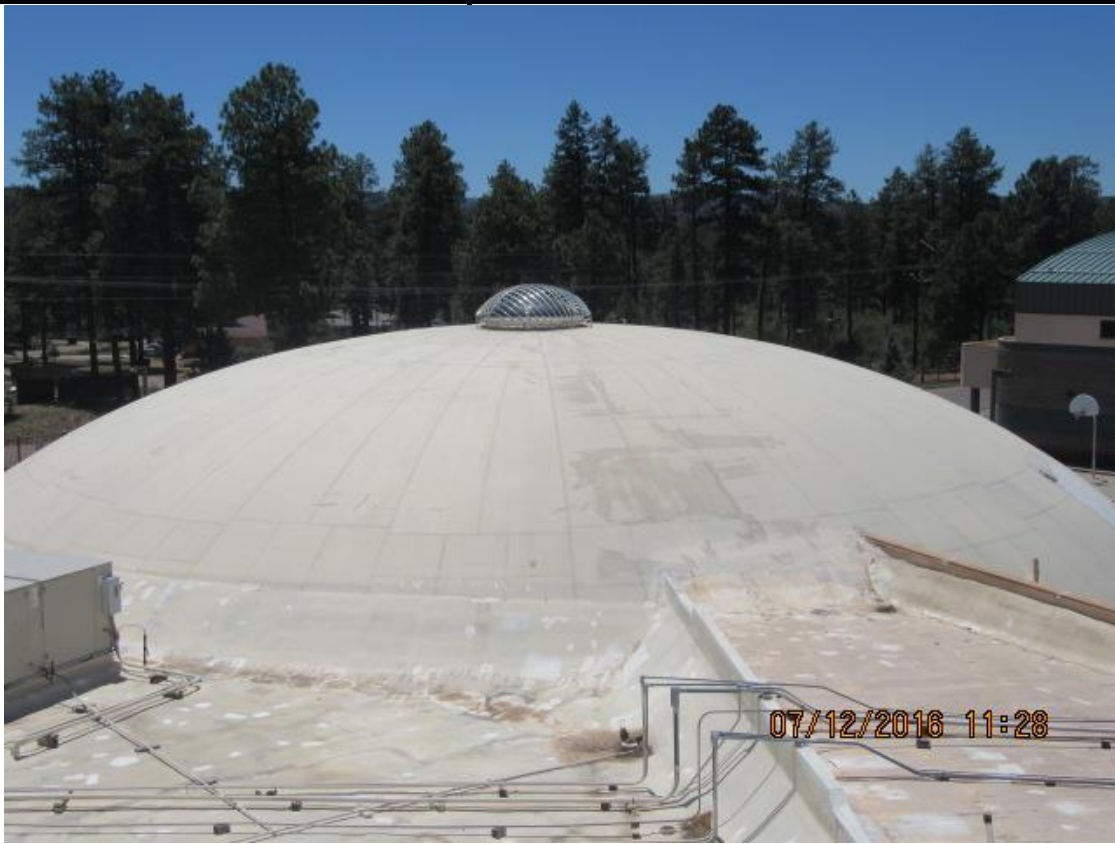
Facility Name/Number & Year Built: Cradleboard Elementary / 1997		Roof Section #: 1	Date of Inspection: 7/12/2016
Roofing System Type: Single Ply		Drainage Adequate: Yes	
Deck Type: Gunitite		Currently Leaking: Yes	
Manufacturer: Unknown		History of Leaks: Yes	
Year Last Roof Installed: 1997		# of Drains: None	
Current Design Life (years): 15		Size of Drains: None	
Life Remaining (years): 1 to 2		# of Scuppers: None	
Building was Built (year): 1997		Size of Scuppers: None	
Roof Access: Ground level and roof hatch		Wall Height above Ground: N/A	
Roof Slope: Dome roof varies		Roof Height below wall: N/A	
Core Information:			
System Type (Ex: BUR, Foam Single Ply, Mod Bit.)	Layer Description (Ex: Fiberglass, TPO, APP)	Attachment Method (Ex: Hot Asphalt, Adhered, Mechanically Attached)	
Single Ply	Hypalon	Adhered	
Current Weight of Roof System by Square Foot: 0.5 pounds			
Roof Condition Index 0 to 100: 50 - Poor

<u>Recommended Corrective Action:</u>			
Year 2016	Activity (Maintenance / Replace/ Recoat) Restoration with recoating		Urgency Moderate
Recommended Roof Replacement - New system type: N/A		Restoration or Repair Description: Clean roof system, removing loose coatings. Repair damages and coat with organic epoxy resin and acrylic coatings.	
Cost: \$ N/A	Year: N/A	Cost: \$	Year: 2016

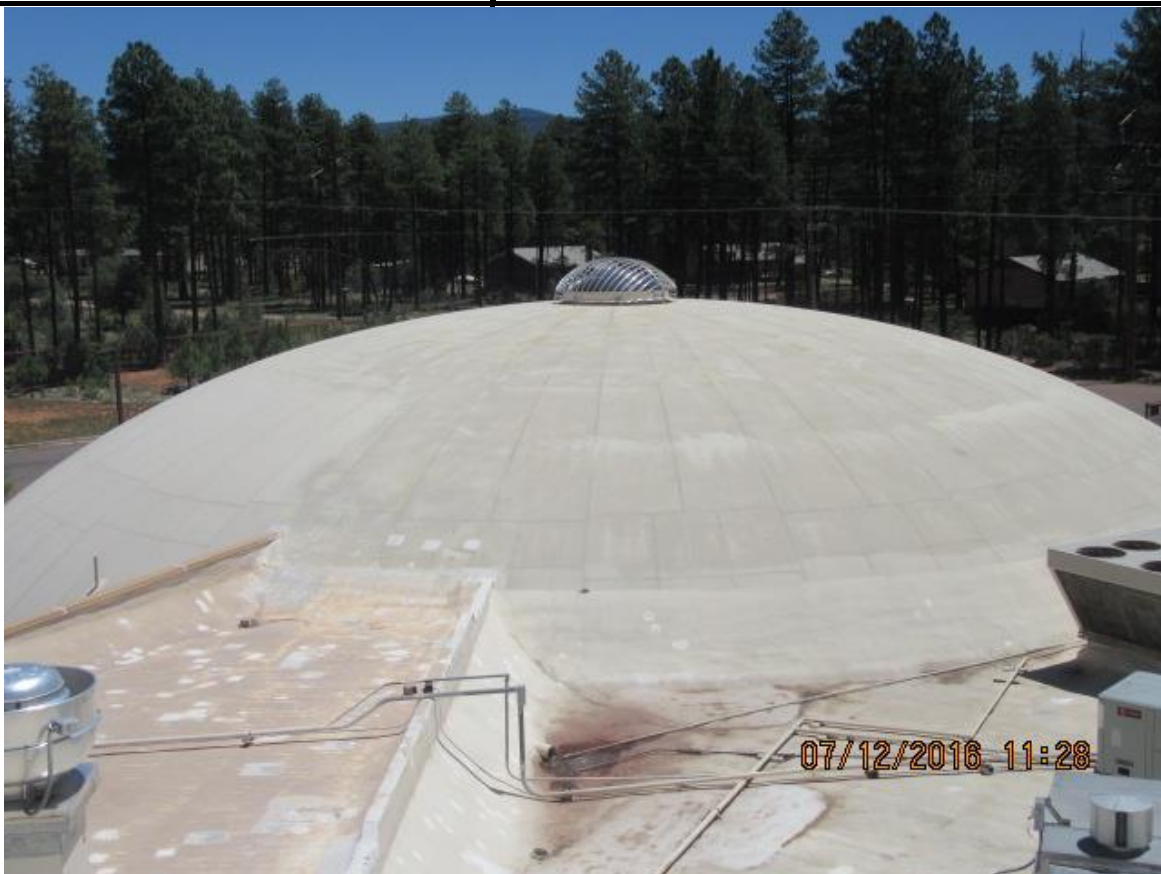
Facility Name/Number & Year Built: Cradleboard Elementary / 1997		Roof Section #: 2	Date of Inspection: 7/12/2016
Roofing System Type: Single Ply		Drainage Adequate: Yes	
Deck Type: Gunitite		Currently Leaking: Yes	
Manufacturer: Unknown		History of Leaks: Yes	
Year Last Roof Installed: 1997		# of Drains: None	
Current Design Life (years): 15		Size of Drains: None	
Life Remaining (years): 1 to 2		# of Scuppers: None	
Building was Built (year): 1997		Size of Scuppers: None	
Roof Access: Ground level and roof hatch		Wall Height above Ground: N/A	
Roof Slope: Dome roof varies		Roof Height below wall: N/A	
Core Information:			
System Type (Ex: BUR, Foam Single Ply, Mod Bit.)	Layer Description (Ex: Fiberglass, TPO, APP)	Attachment Method (Ex: Hot Asphalt, Adhered, Mechanically Attached)	
Single Ply	Hypalon	Adhered	
Current Weight of Roof System by Square Foot: 0.5 pounds			
Roof Condition Index 0 to 100: 50 - Poor

<u>Recommended Corrective Action:</u>			
Year 2016	Activity (Maintenance / Replace/ Recoat) Restoration with recoating	Urgency Moderate	
Recommended Roof Replacement - New system type: N/A		Restoration or Repair Description: Clean roof system, removing loose coatings. Repair damages and coat with organic epoxy resin and acrylic coatings.	
Cost: \$ N/A	Year: N/A	Cost: \$	Year: 2016

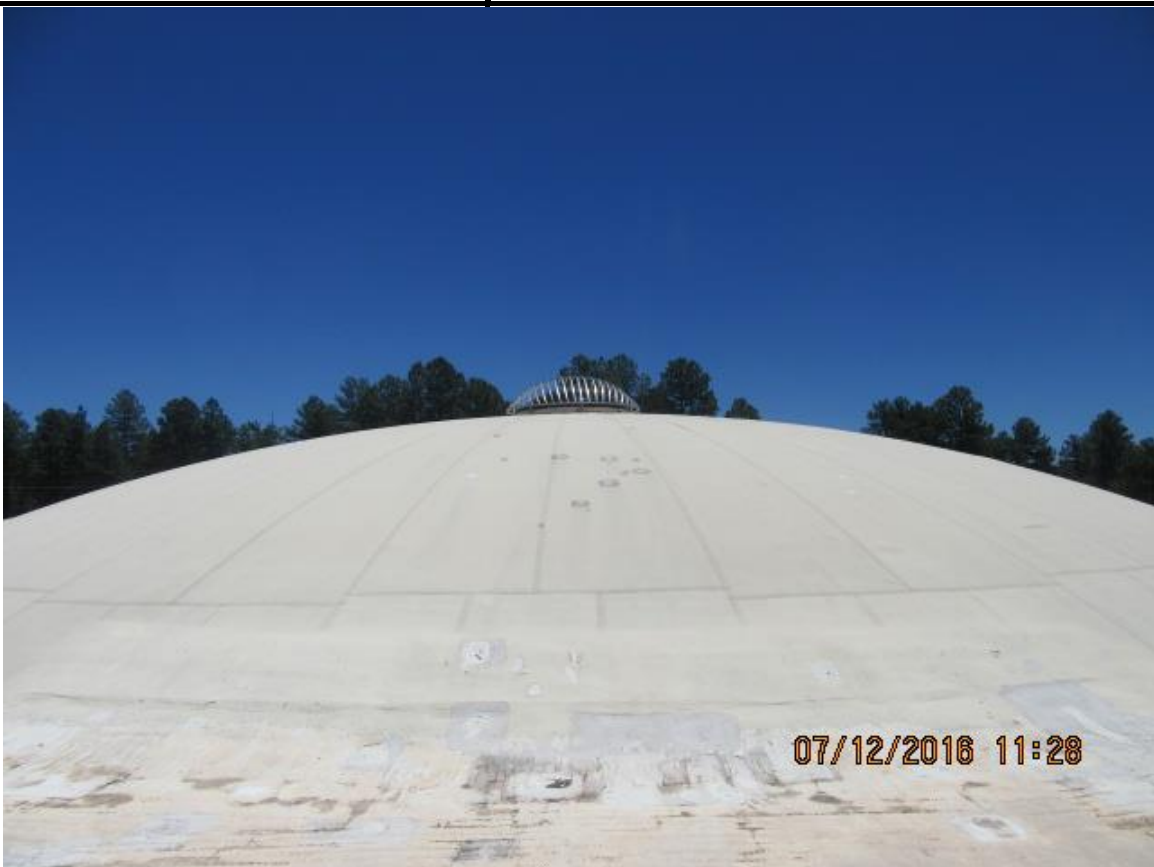
Facility Name/Number & Year Built: Cradleboard Elementary / 1997		Roof Section #: 3	Date of Inspection: 7/12/2016
Roofing System Type: Single Ply		Drainage Adequate: Yes	
Deck Type: Gunitite		Currently Leaking: Yes	
Manufacturer: Unknown		History of Leaks: Yes	
Year Last Roof Installed: 1997		# of Drains: None	
Current Design Life (years): 15		Size of Drains: None	
Life Remaining (years): 1 to 2		# of Scuppers: None	
Building was Built (year): 1997		Size of Scuppers: None	
Roof Access: Ground level and roof hatch		Wall Height above Ground: N/A	
Roof Slope: Dome roof varies		Roof Height below wall: N/A	
Core Information:			
System Type (Ex: BUR, Foam Single Ply, Mod Bit.)	Layer Description (Ex: Fiberglass, TPO, APP)	Attachment Method (Ex: Hot Asphalt, Adhered, Mechanically Attached)	
Single Ply	Hypalon	Adhered	
Current Weight of Roof System by Square Foot: 0.5 pounds			
Roof Condition Index 0 to 100: 50 - Poor

<u>Recommended Corrective Action:</u>			
Year 2016	Activity (Maintenance / Replace/ Recoat) Restoration with recoating	Urgency Moderate	
Recommended Roof Replacement - New system type: N/A		Restoration or Repair Description: Clean roof system, removing loose coatings. Repair damages and coat with organic epoxy resin and acrylic coatings.	
Cost: \$ N/A	Year: N/A	Cost: \$	Year: 2016

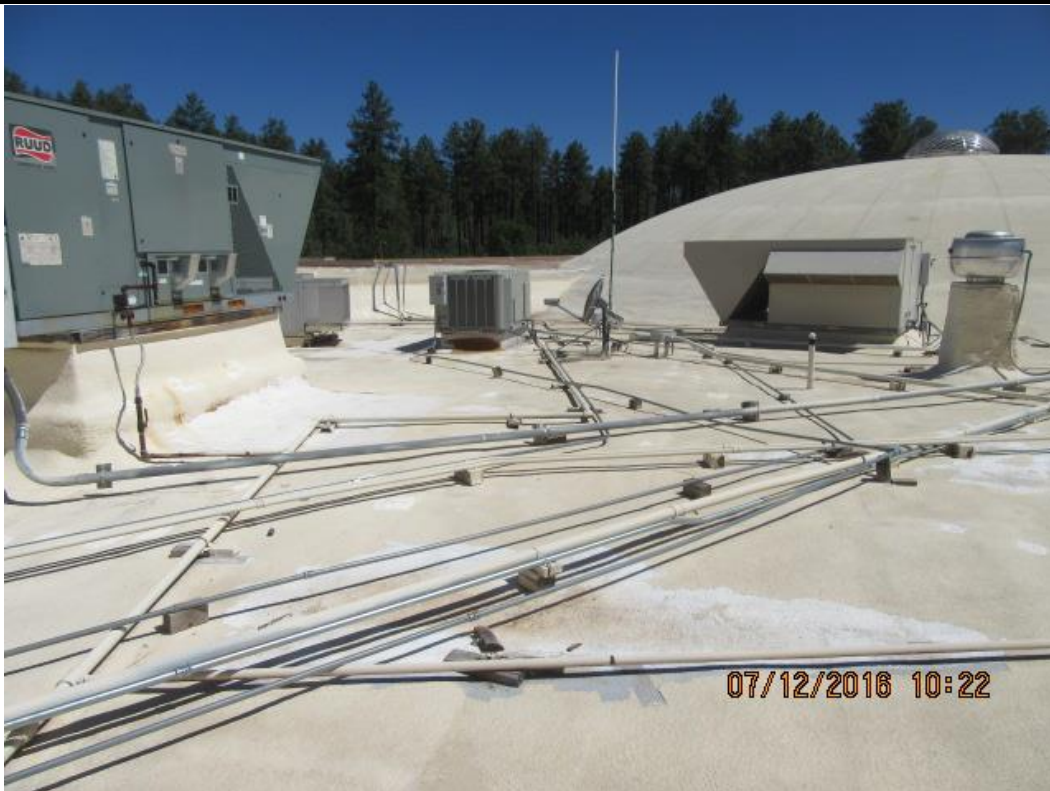
Facility Name/Number & Year Built: Cradleboard Elementary / 1997	Roof Section #: 4	Date of Inspection: 7/12/2016
Roofing System Type: Coated foam	Drainage Adequate: No	
Deck Type: Lightweight concrete over steel	Currently Leaking: Yes	
Manufacturer: Unknown	History of Leaks: Yes	
Year Last Roof Installed: 1997	# of Drains: 4 primary & 4 overflow	
Current Design Life (years): 10	Size of Drains: 6"	
Life Remaining (years): 0 to 1	# of Scuppers: None	
Building was Built (year): 1997	Size of Scuppers: None	
Roof Access: Roof hatch	Wall Height above Ground: 15' to 16'	
Roof Slope: Average 1/4" per foot	Roof Height below wall: 2' to 3'

Roof Condition Index 0 to 100: 25 - Urgent

Tear out 4' wide at dome to flat roof and adjacent parapet walls at drains. Install new 3 lb. foam. Clean roof system, removing loose coatings. Repair damages and coat entire roof with organic epoxy resin and acrylic coatings.

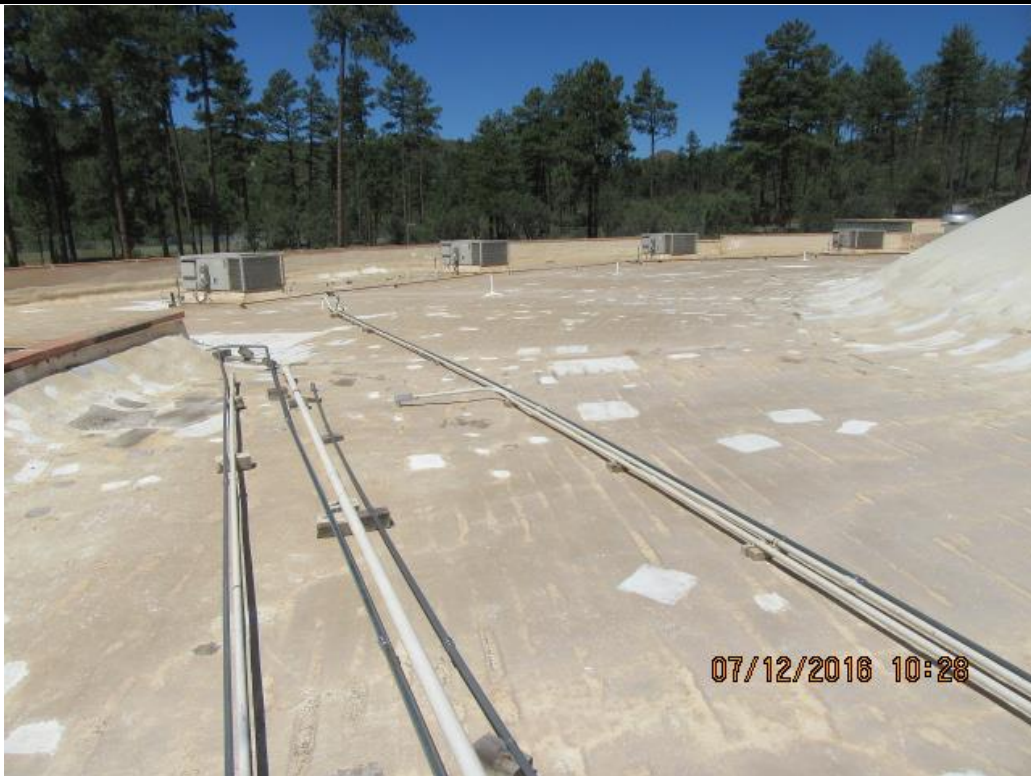
Facility Name/Number & Year Built: Cradleboard Elementary / 2002	Roof Section #: 5	Date of Inspection: 7/12/2016
Roofing System Type: Coated foam	Drainage Adequate: Yes	
Deck Type: Metal B-decking	Currently Leaking: Yes	
Manufacturer: Unknown	History of Leaks: Yes	
Year Last Roof Installed: 2002	# of Drains: 1 primary & 1 overflow scupper 2" X 8"	
Current Design Life (years): 10	Size of Drains: 6"	
Life Remaining (years): 0 to 1	# of Scuppers: 3	
Building was Built (year): 2002	Size of Scuppers: 8" X 8" Primary Scuppers	
Roof Access: Roof hatch	Wall Height above Ground: 15' to 16'	
Roof Slope: Average 1/2" per foot	Roof Height below wall: 2' to 3'

Roof Condition Index 0 to 100: 50 - Poor

Tear out 4' wide at dome to flat roof and adjacent parapet walls at drains. Install new 3 lb. foam. Clean roof system, removing loose coatings. Repair damages and coat entire roof with organic epoxy resin and acrylic coatings.

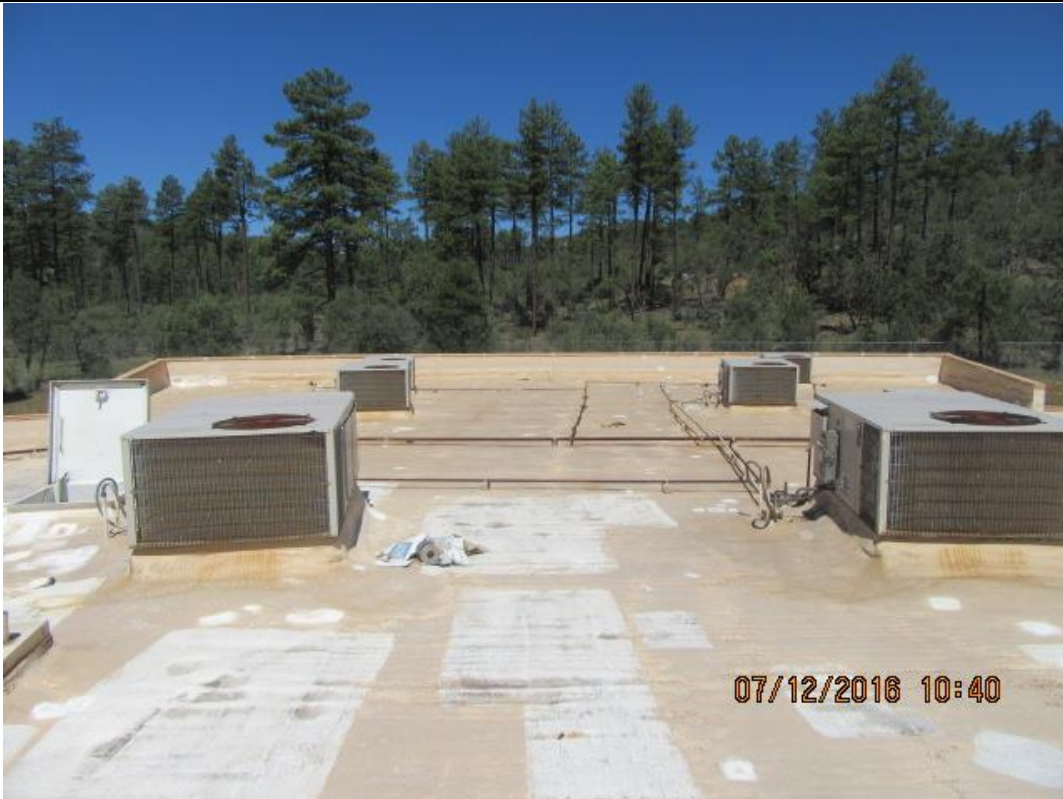
Facility Name/Number & Year Built: Cradleboard Elementary / 2002		Roof Section #: 6	Date of Inspection: 7/12/2016
Roofing System Type: Coated foam		Drainage Adequate: Yes	
Deck Type: Metal B-decking		Currently Leaking: Yes	
Manufacturer: Unknown		History of Leaks: Yes	
Year Last Roof Installed: 2002		# of Drains: None	
Current Design Life (years): 10		Size of Drains: 6"	
Life Remaining (years): 2		# of Scuppers: 2	
Building was Built (year): 2002		Size of Scuppers: 8" X 8" Primary Scuppers	
Roof Access: Roof hatch		Wall Height above Ground: 15' to 16'	
Roof Slope: Average 1/2" per foot		Roof Height below wall: 2' to 3'	
Core Information:			
System Type (Ex: BUR, Foam Single Ply, Mod Bit.)	Layer Description (Ex: Fiberglass, TPO, APP)	Attachment Method (Ex: Hot Asphalt, Adhered, Mechanically Attached)	
Coated Foam	Coatings over foam over taped flutes of metal deck	Adhered	
Current Weight of Roof System by Square Foot: 0.75 pounds

Roof Condition Index 0 to 100: 50 - Poor			
Recommended Corrective Action:			
Year 2016	Activity (Maintenance / Replace/ Recoat) Repair & Restoration with Coating		Urgency High
Recommended Roof Replacement - New system type: N/A		Restoration or Repair Description: Tear out 4' wide at dome to flat roof and adjacent parapet walls at drains. Install new 3 lb. foam. Clean roof system, removing loose coatings. Repair damages and coat entire roof with organic epoxy resin and acrylic coatings.

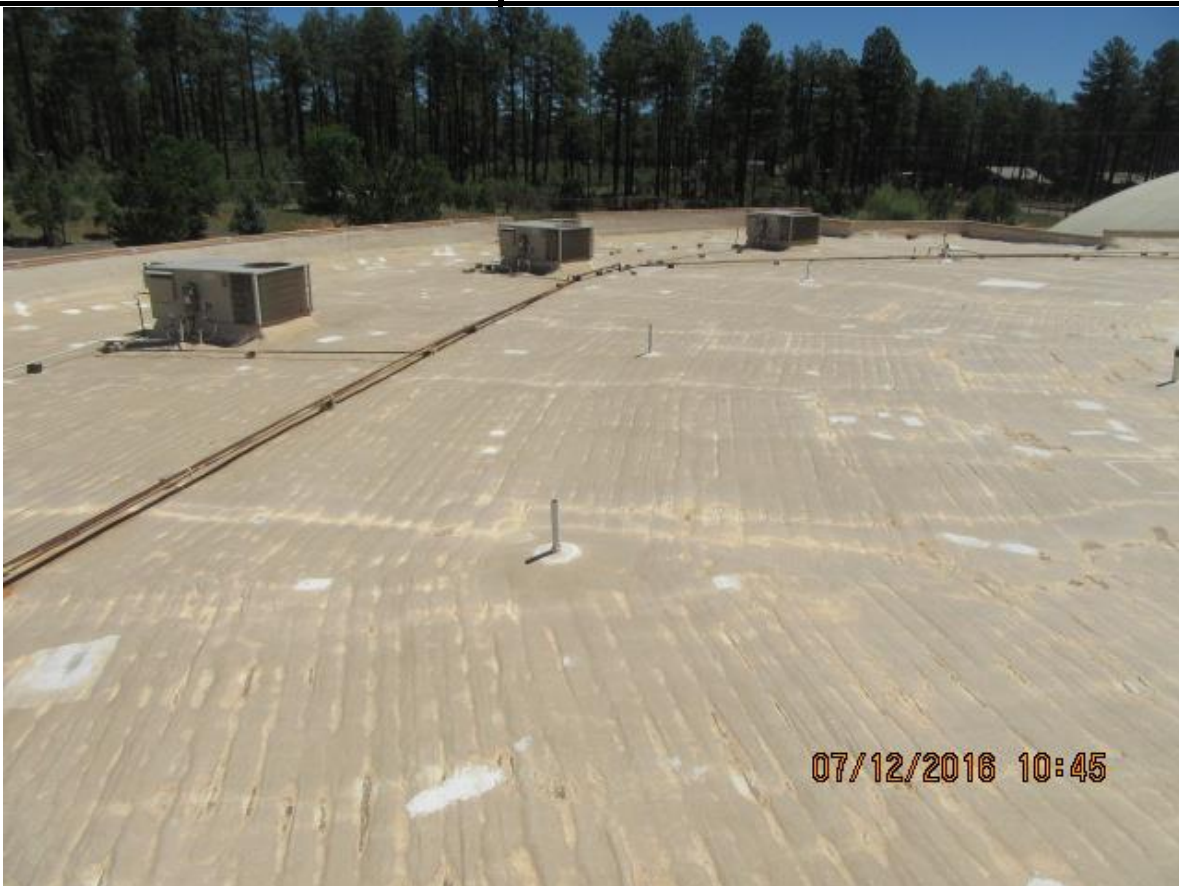
Facility Name/Number & Year Built: Cradleboard Elementary / 2002		Roof Section #: 7	Date of Inspection: 7/12/2016
Roofing System Type: Coated foam		Drainage Adequate: Yes	
Deck Type: Metal B-decking		Currently Leaking: Yes	
Manufacturer: Unknown		History of Leaks: Yes	
Year Last Roof Installed: 2002		# of Drains: 1 primary	
Current Design Life (years): 10		Size of Drains: 6"	
Life Remaining (years): 0 to 1		# of Scuppers: 3	
Building was Built (year): 2002		Size of Scuppers: 8" X 8" Primary Scuppers	
Roof Access: Roof hatch		Wall Height above Ground: 15' to 16'	
Roof Slope: Average 1/2" per foot		Roof Height below wall: 2' to 3'	
Core Information:			
System Type (Ex: BUR, Foam Single Ply, Mod Bit.)	Layer Description (Ex: Fiberglass, TPO, APP)	Attachment Method (Ex: Hot Asphalt, Adhered, Mechanically Attached)	
Coated Foam	Coatings over foam over taped flutes of metal deck	Adhered	
Current Weight of Roof System by Square Foot: 0.75 pounds

Roof Condition Index 0 to 100: 50 - Poor			
Recommended Corrective Action:			
Year	Activity (Maintenance / Replace/ Recoat)	Urgency	
2016	Repair & Restoration with Coating	High	
Recommended Roof Replacement - New system type: N/A		Restoration or Repair Description: Tear out 4' wide at dome to flat roof and adjacent parapet walls at drains. Install new 3 lb. foam. Clean roof system, removing loose coatings. Repair damages and coat entire roof with organic epoxy resin and acrylic coatings.	
Cost: \$	N/A	Year: N/A	
Cost: \$		Year: 2016
