Cradleboard Elementary School  
7301 Power Line Rd.  
Whiteriver, AZ 85941

Project: Roof Assessment

Inspection Date: 7/12/2016

Inspector: Jerry Brown, RRO & Bryan Hill, RRO

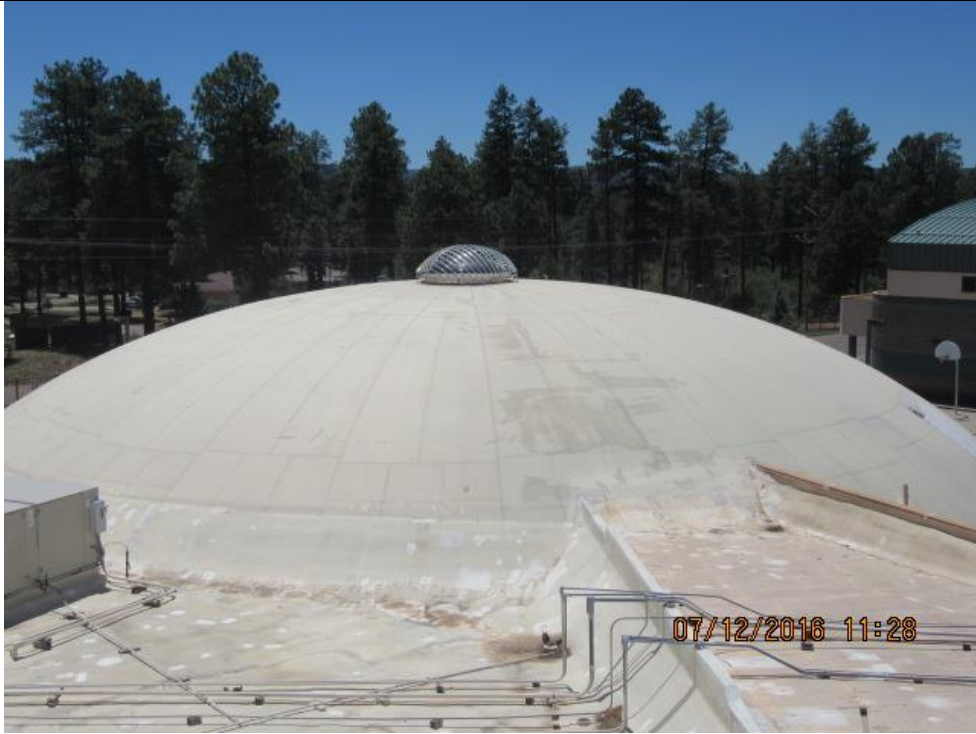
Photo # 1

Description: Roof #1

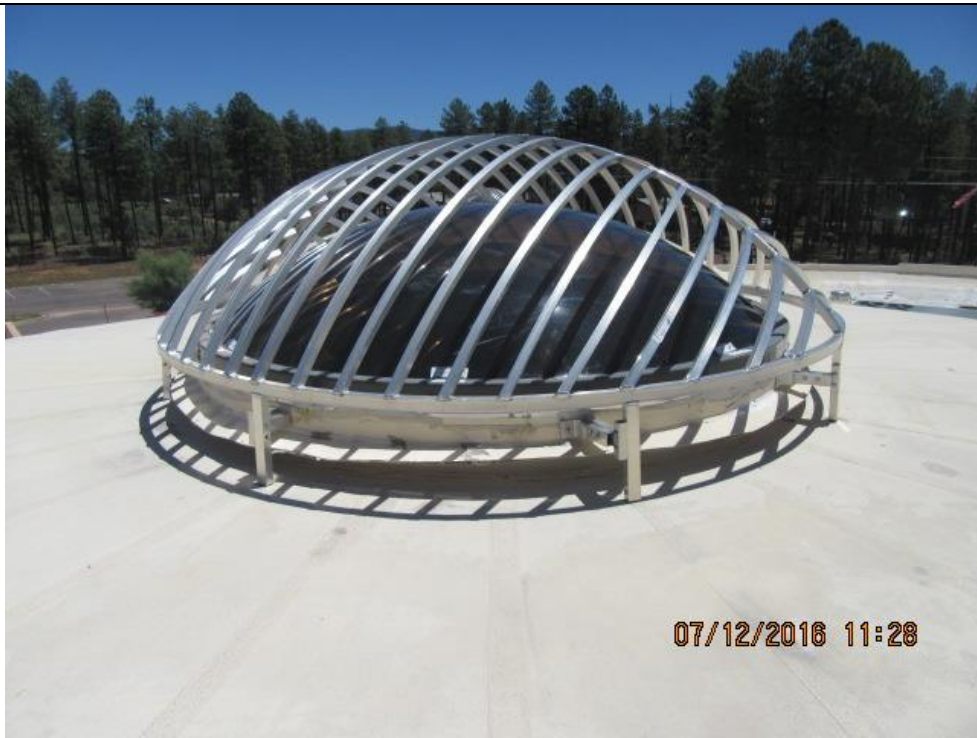
Photo # 2

Description: Roof #1

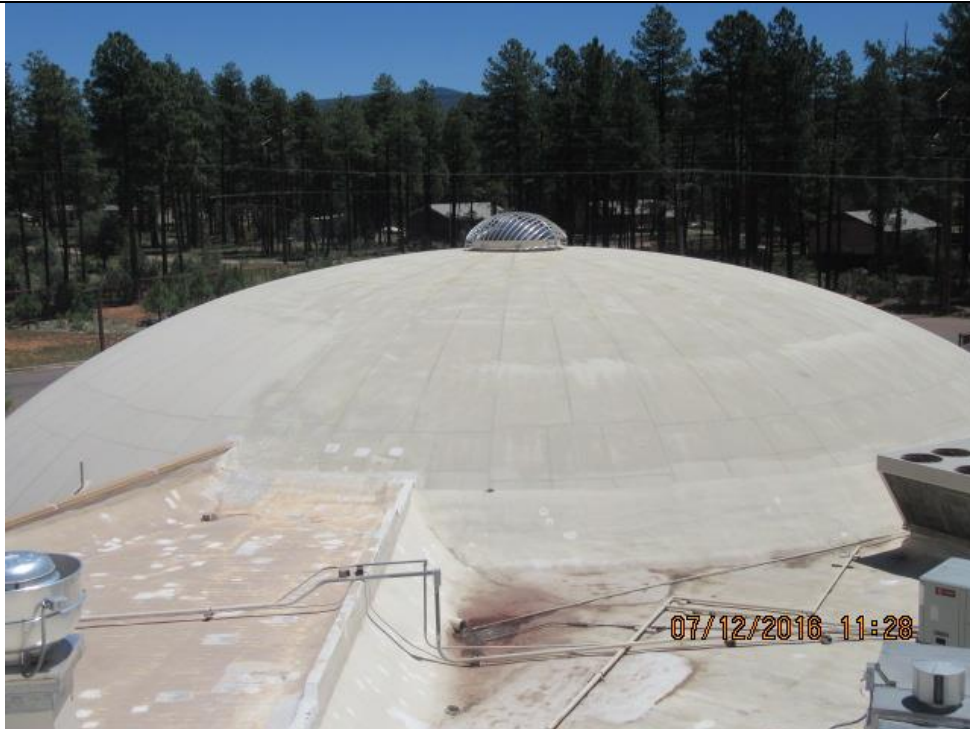
Photo # 3

Description: Roof #2

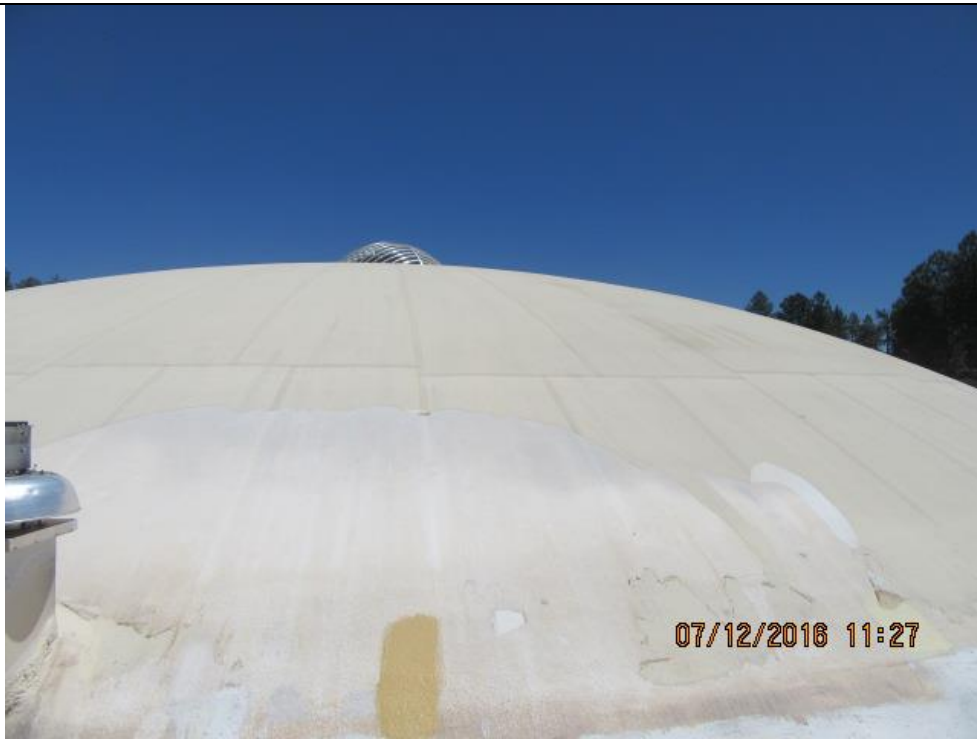
Photo # 4

Description: Roof #2

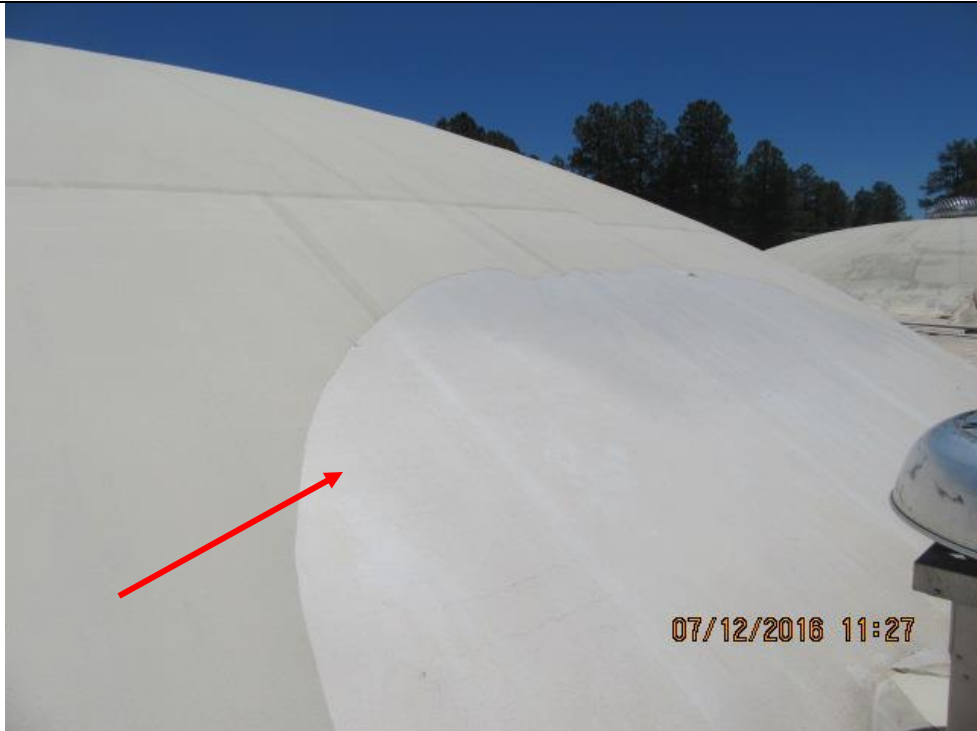
Photo # 5

Description: Roof #3. Note the coatings have been peeled off of the roofing system.

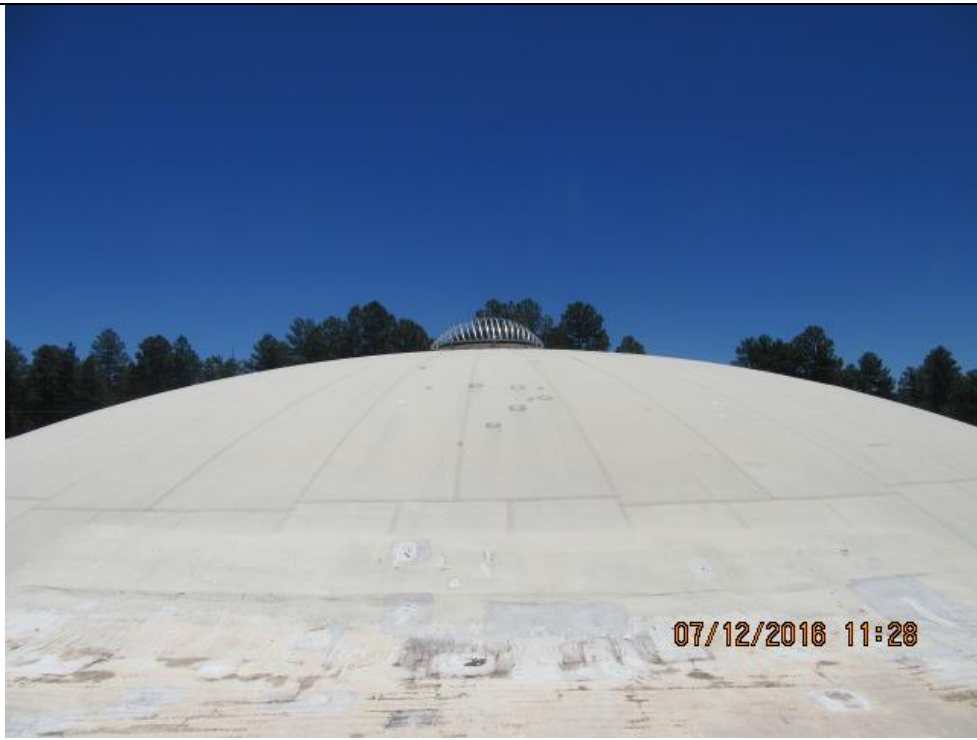
Photo # 6

Description: Roof #3

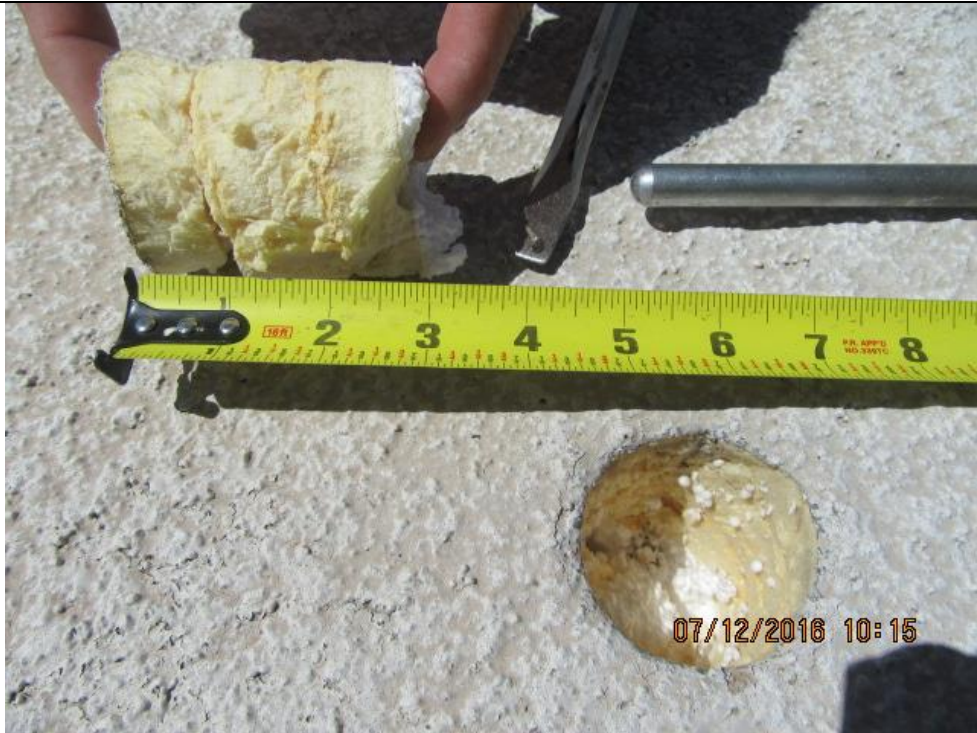
Photo # 7

Description: Roof #4, core sample.

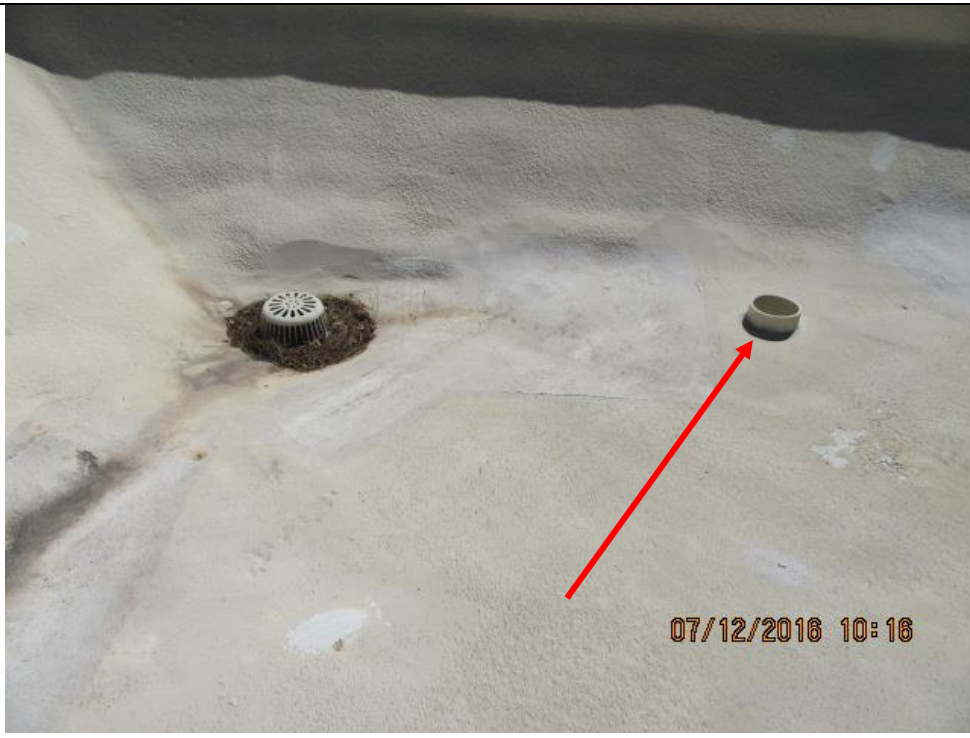
Photo # 8

Description: Roof #4, typical drain set up. Note the distance the overflow drain is and how much higher.

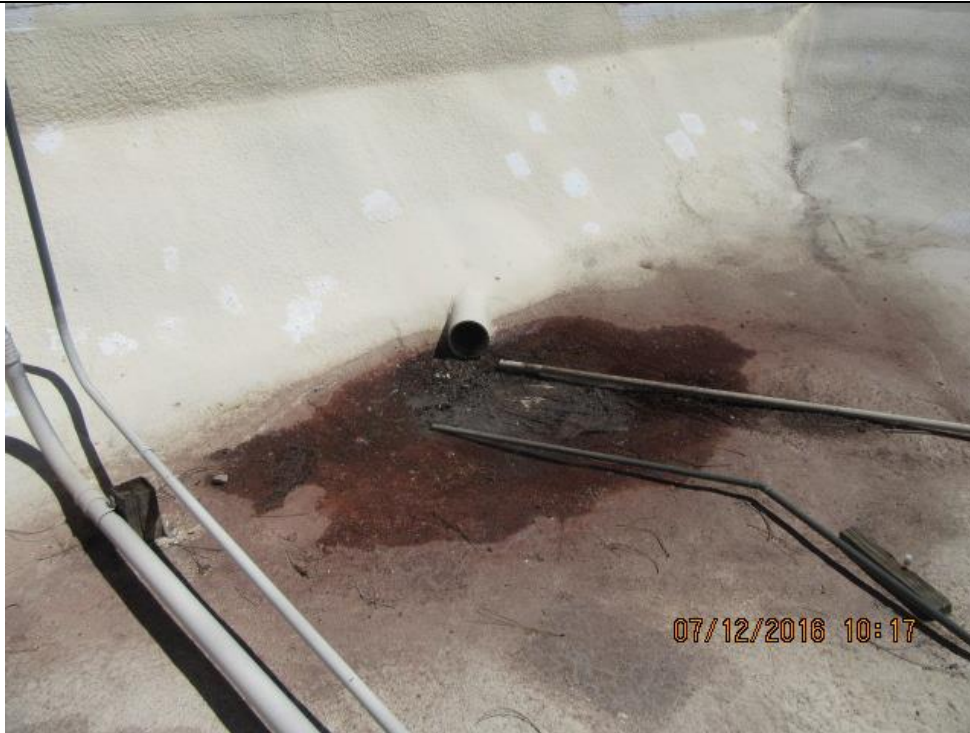
Photo # 9

Description: Roof #4, primary drain is clogged.

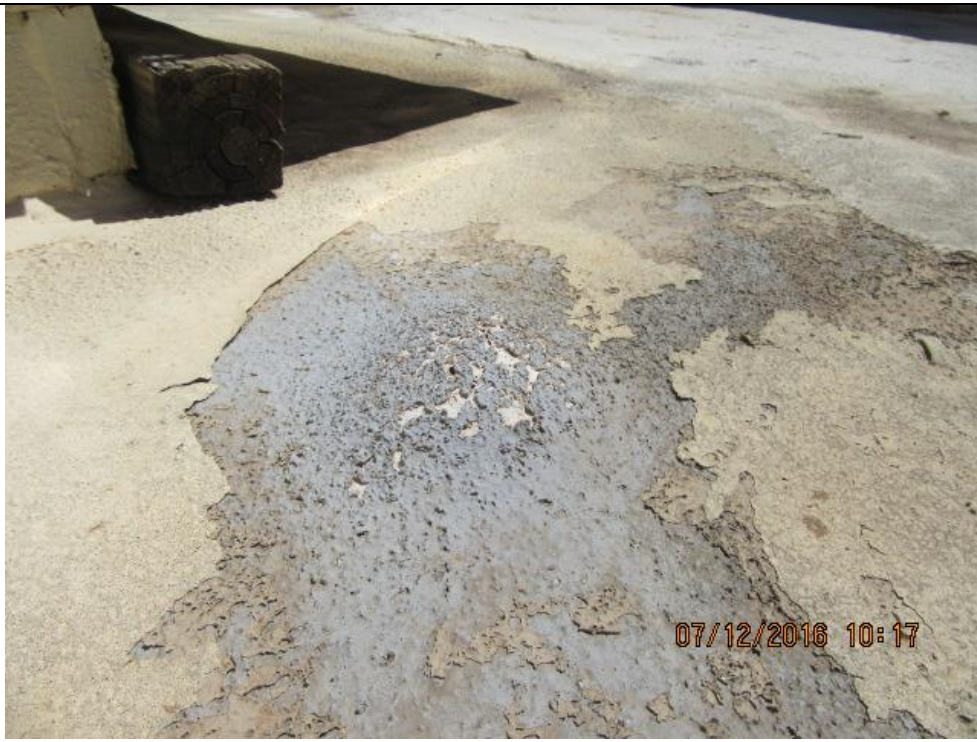
Photo # 10

Description: Roof #4, typical coatings peeled off.

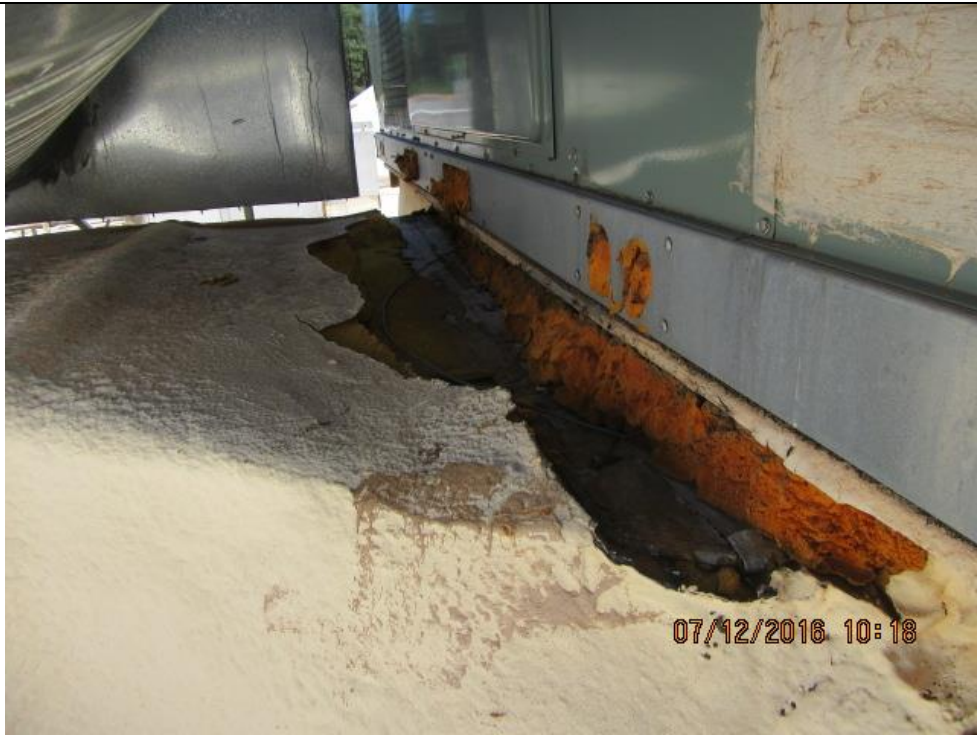
Photo # 11

Description: Roof #4, HVAC curb, poor construction detailing.

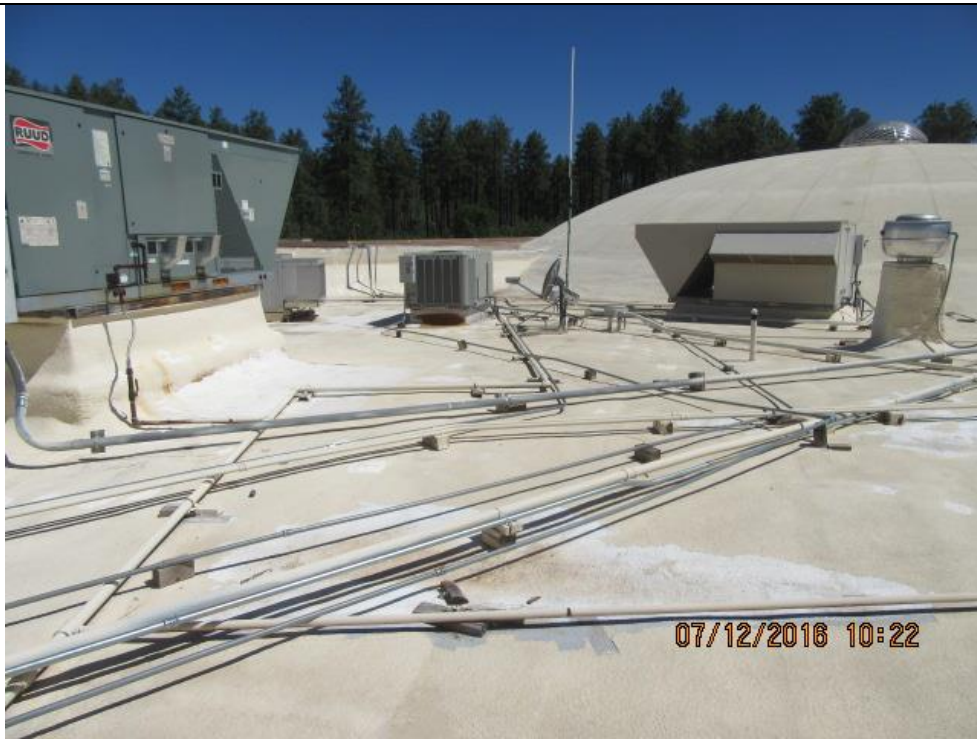
Photo # 12

Description: Roof #4, typical cluster of pipes, conduit and gas line. None of which are properly supported.

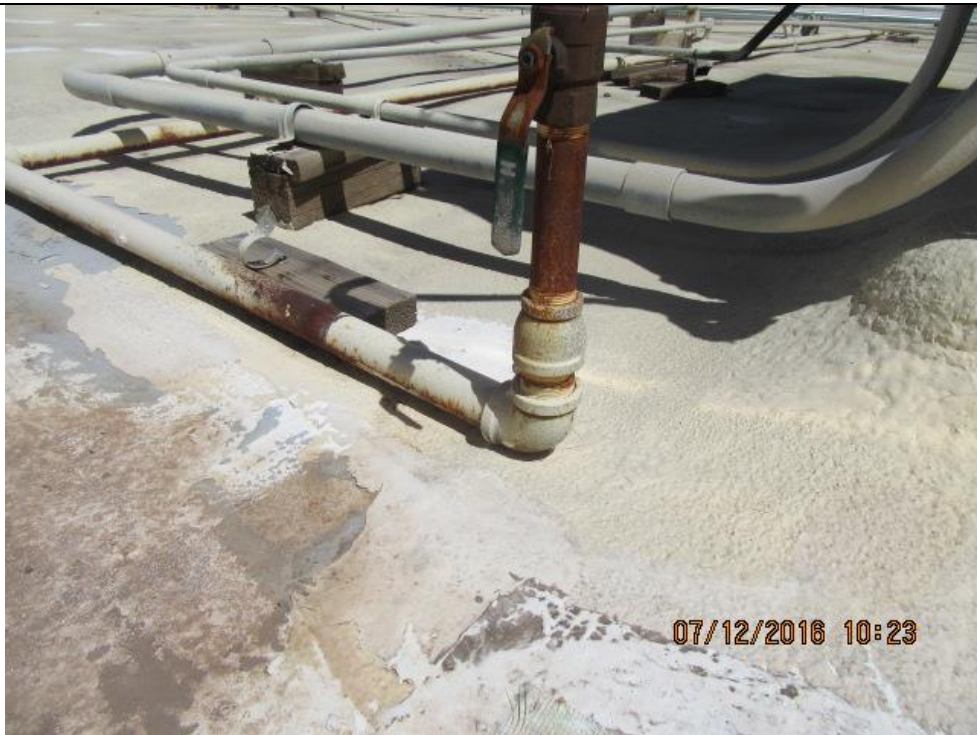
Photo # 13

Description: Roof #4, Typical gas line condition.

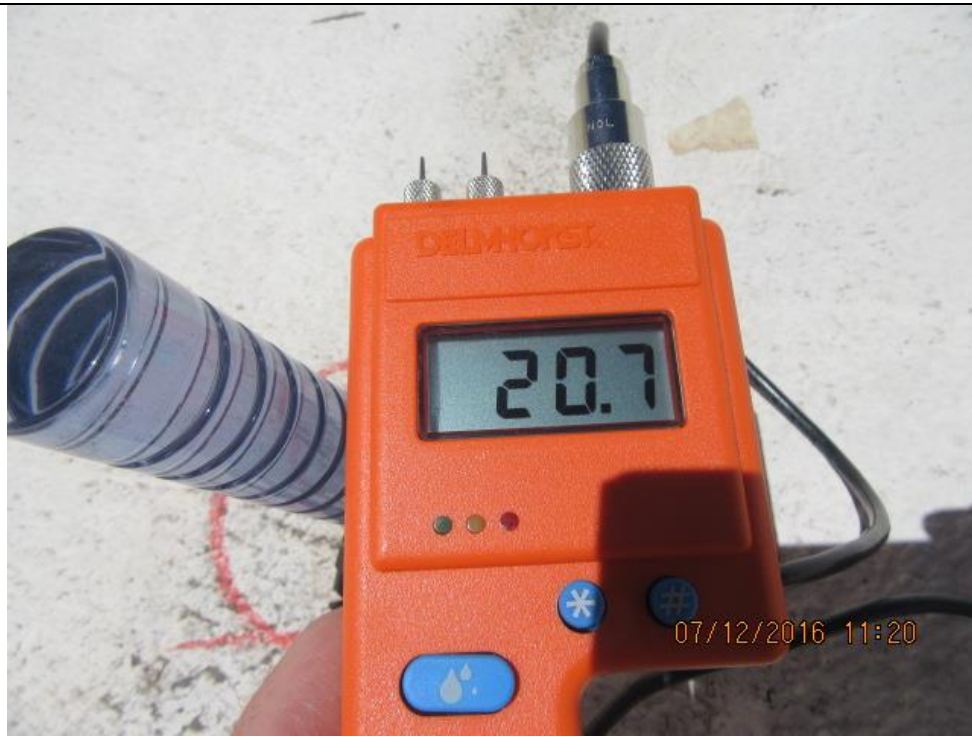
Photo # 14

Description: Roof #4, low moisture reading. Anything above 10% is problematic.

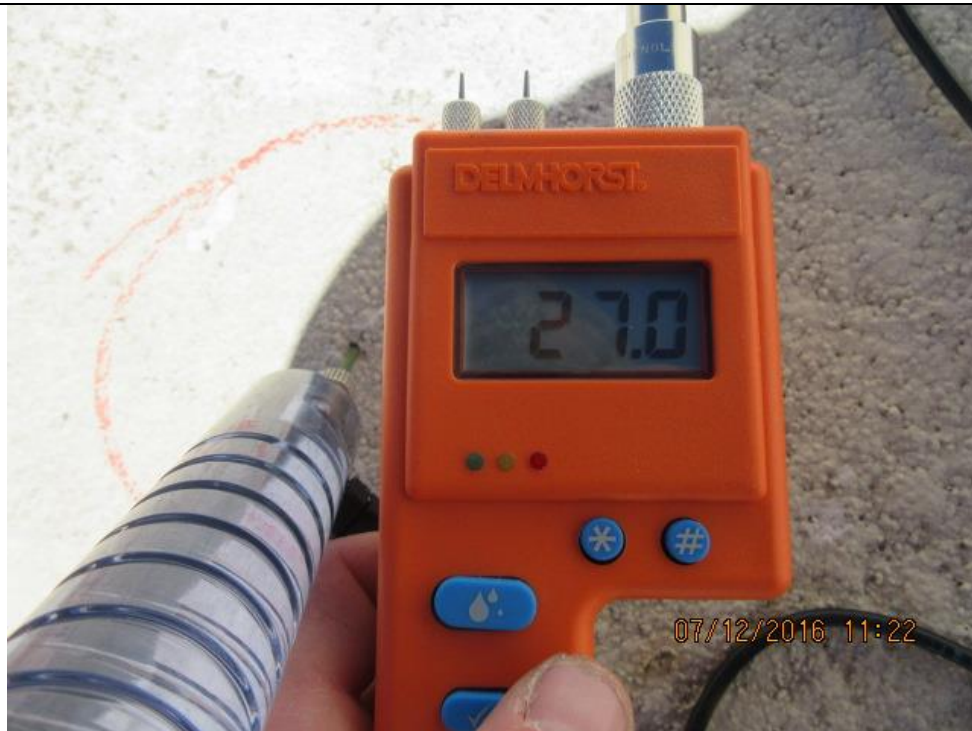
Photo # 15

Description: Roof #4, typical high reading.

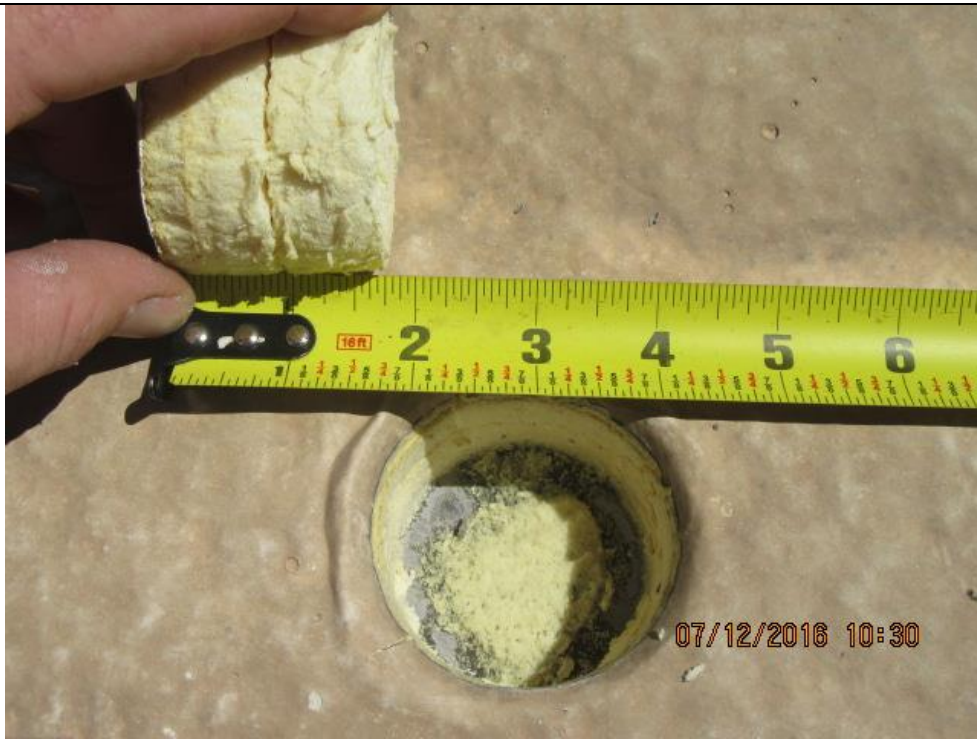
Photo # 16

Description: Roof #5, core sample.

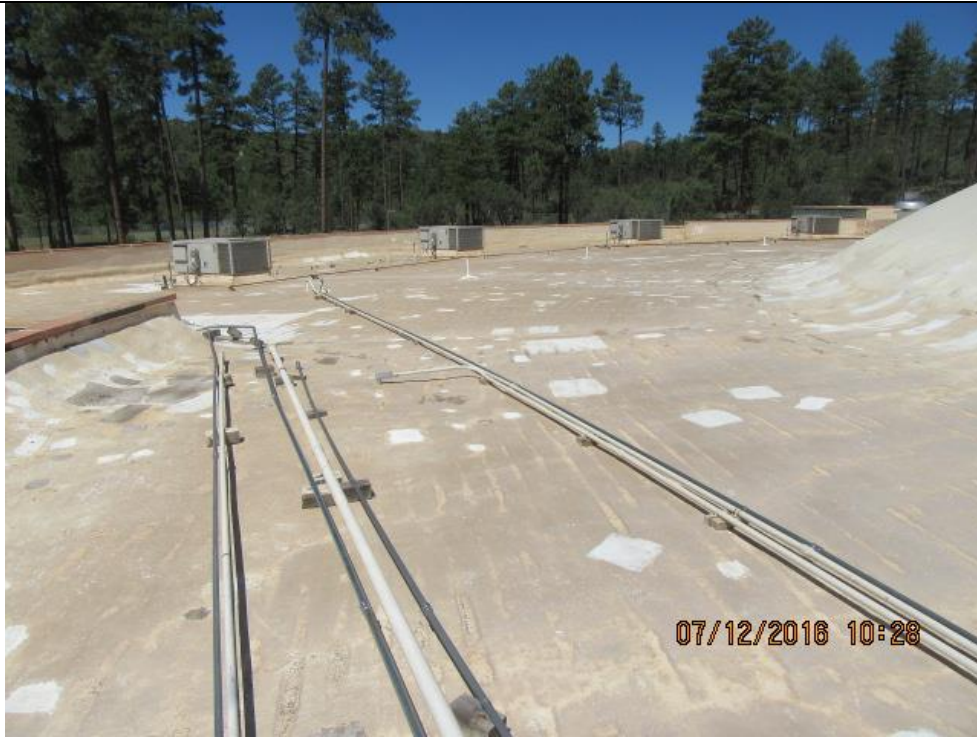
Photo # 17

Description: Roof #5, typical condition.

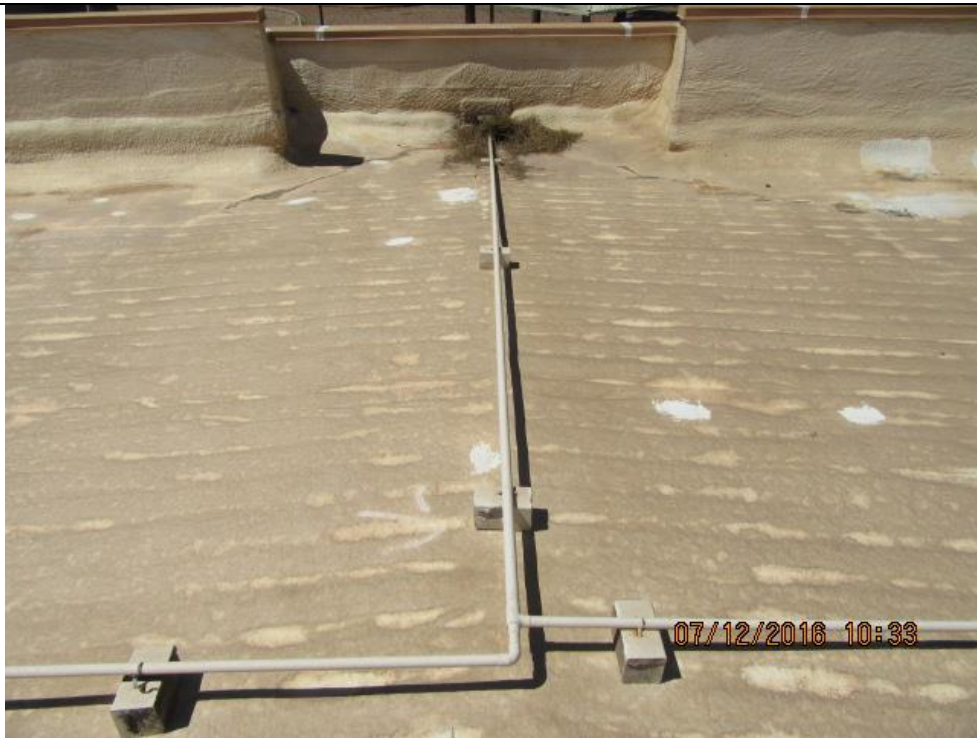
Photo # 18

Description: Roof #5, typical condition.

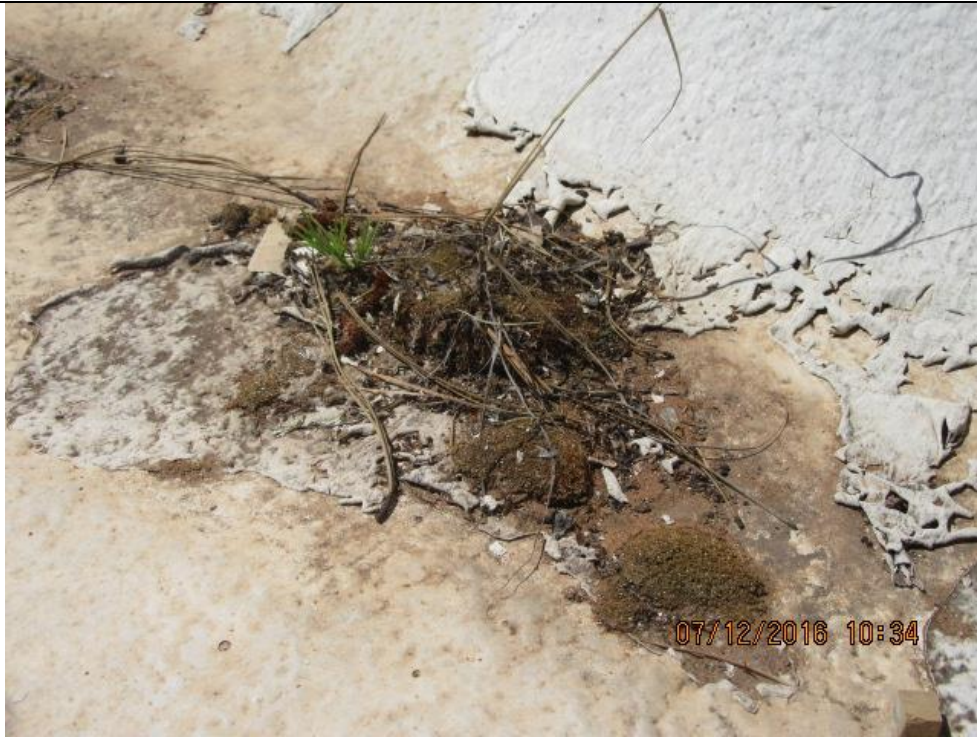
Photo # 19

Description: Roof #5, vegetation growing out of the foam roof.

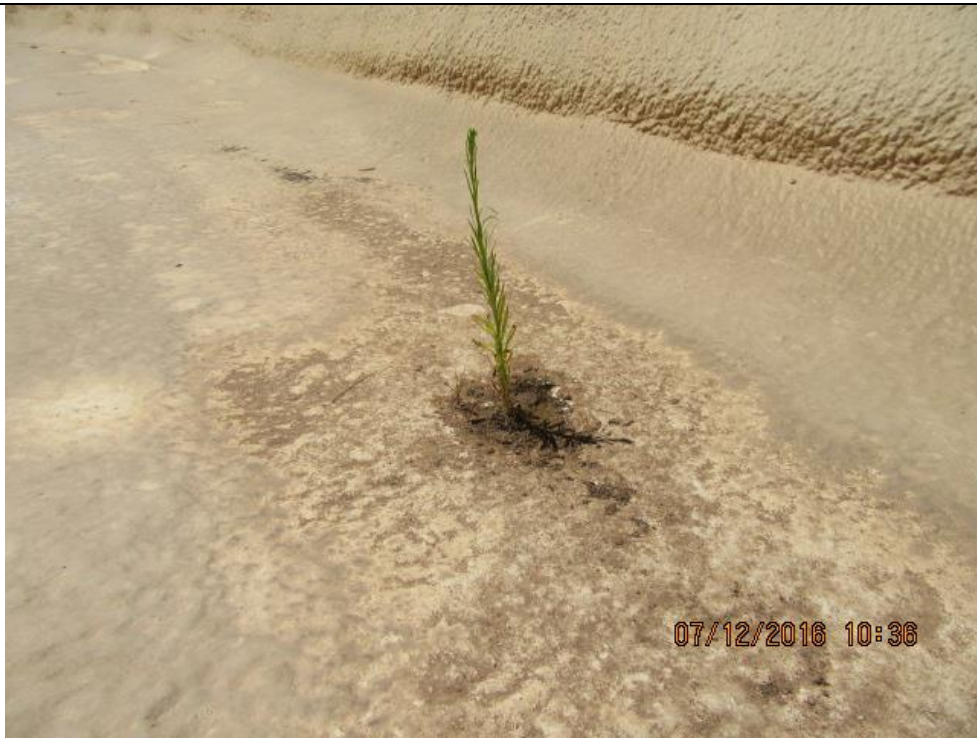
Photo # 20

Description: Roof #5, vegetation growing out of the foam roof.

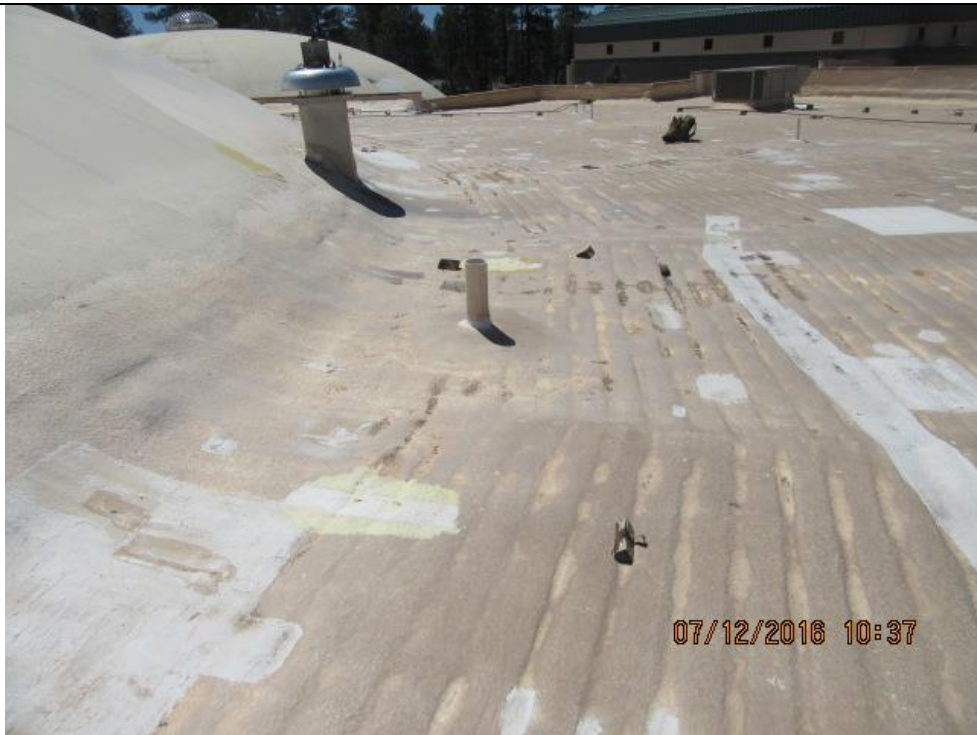
Photo # 21

Description: Roof #5, typical result of contractor taping flutes. The foam will not rise as high on tape flutes leaving sunken areas everywhere. This leads to ponding issues and deterioration of the roofing system.

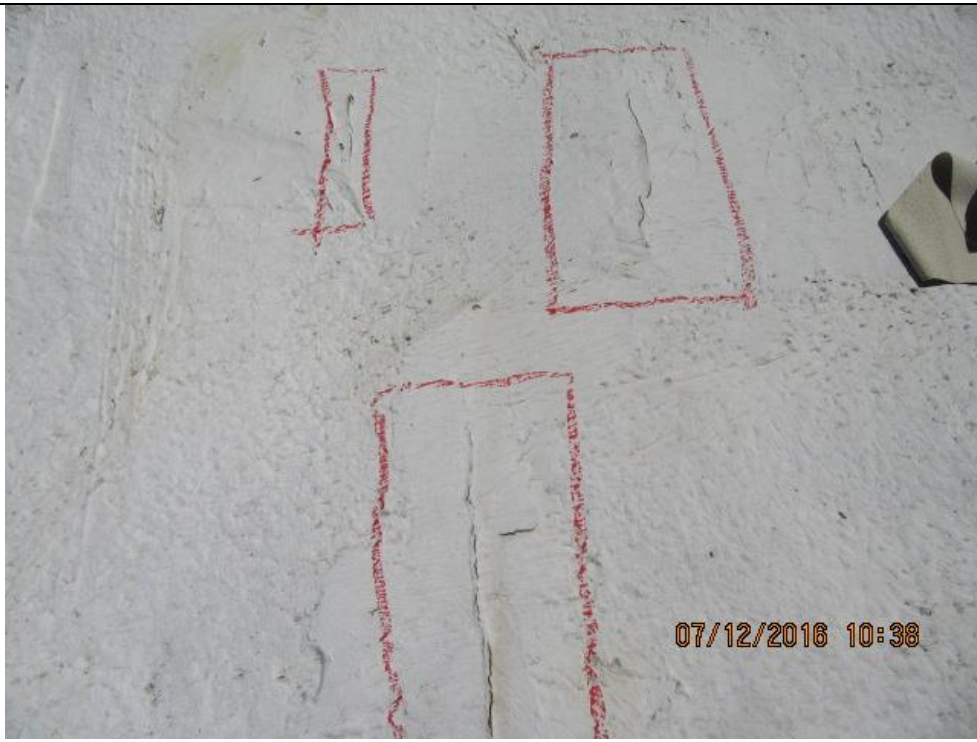
Photo # 22

Description: Roof #5, typical fracturing of the roof system, believed to be caused by skateboarders on the roof.

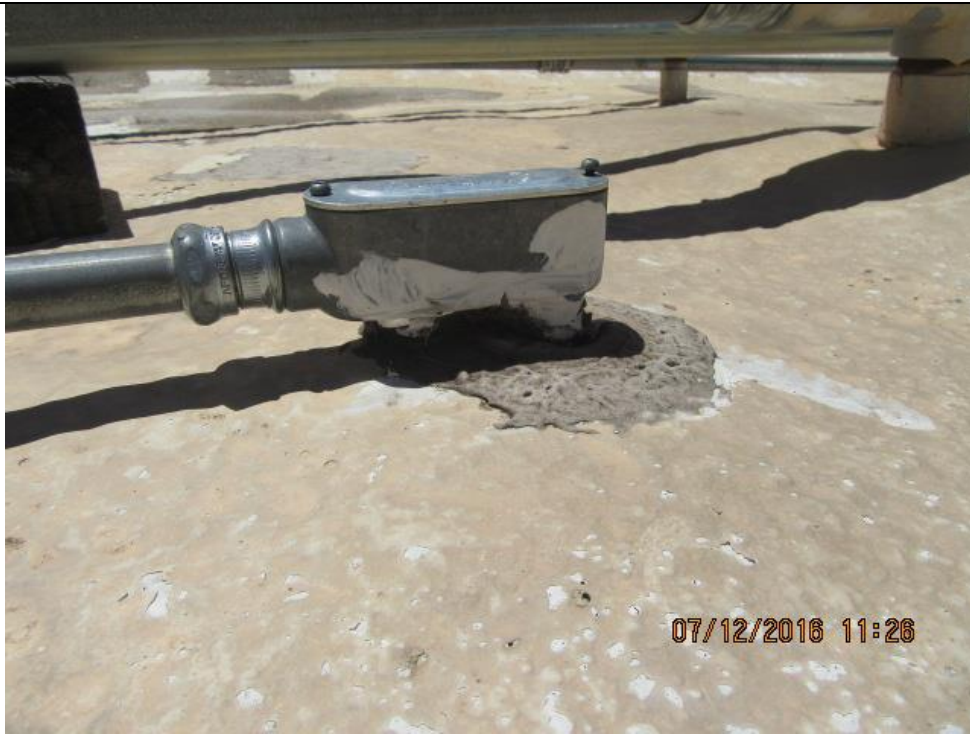
Photo # 23

Description: Roof #5, recently installed electrical conduit installed incorrectly. Must be a minimum 8" above the roof surface.

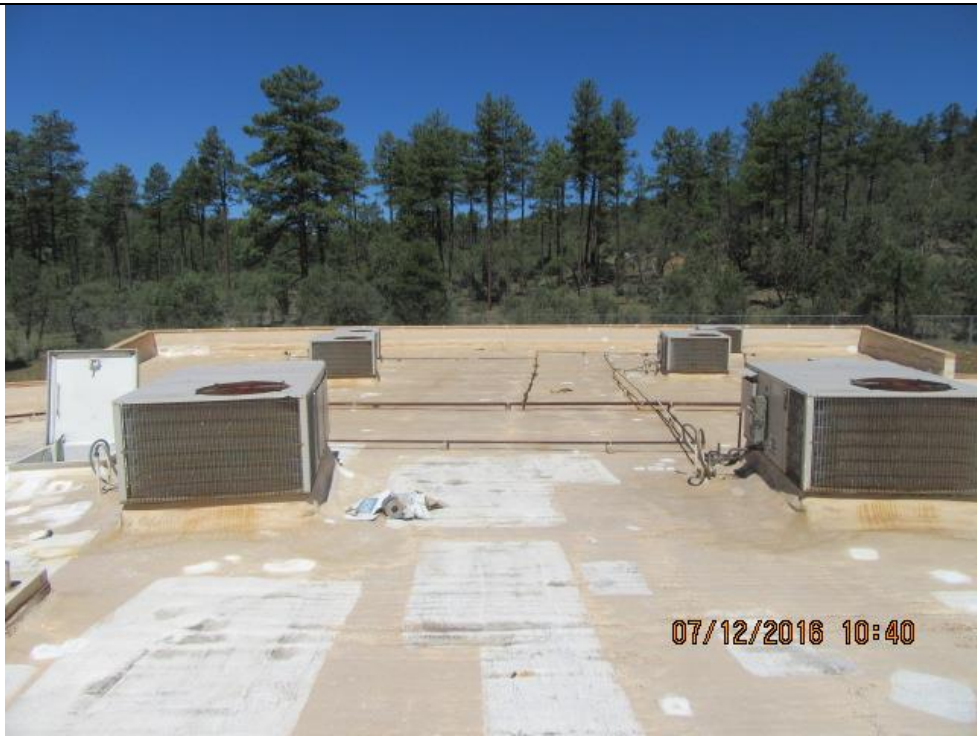
Photo # 24

Description: Roof #6, typical view with multiple patches.

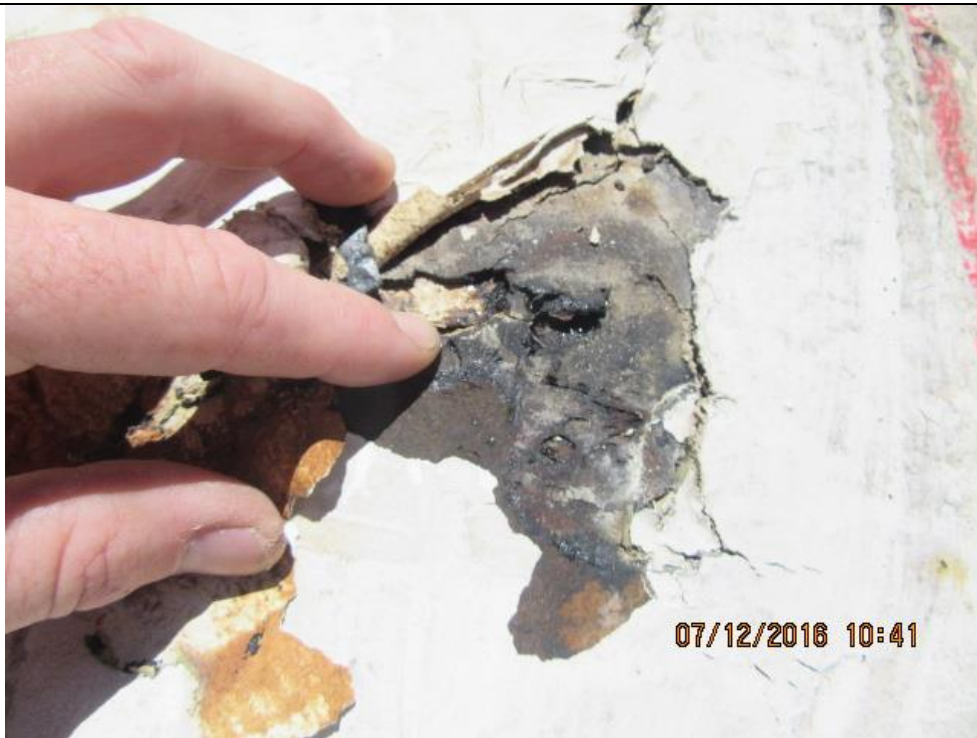
Photo # 25

Description: Roof #6, deteriorated damaged area allowing water entry into the building.

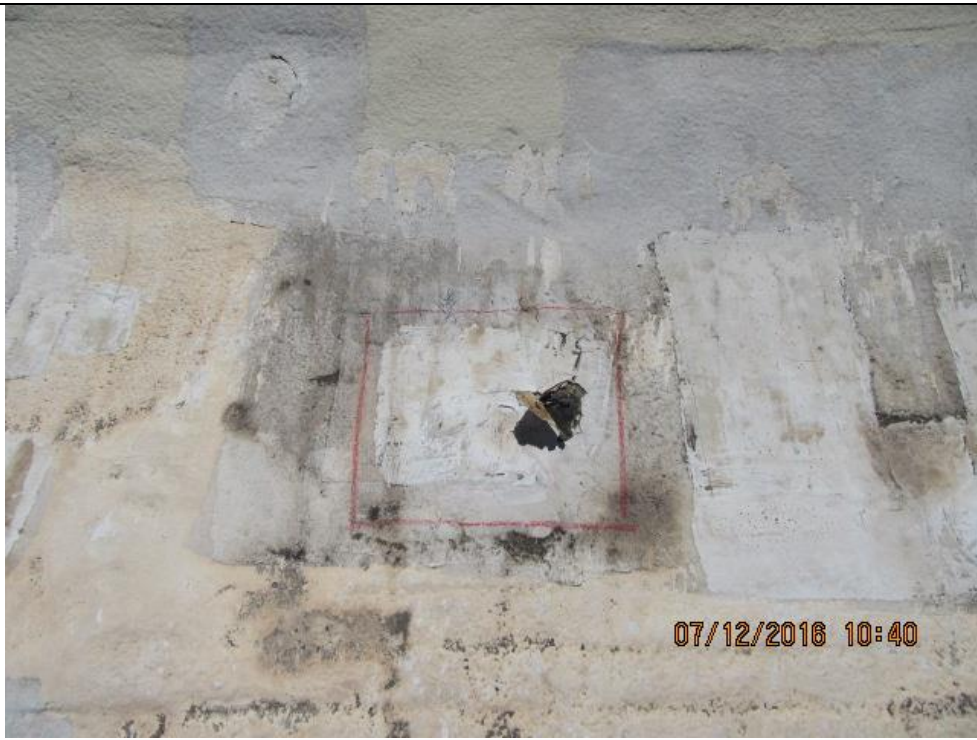
Photo # 26

Description: Roof #6, typical damaged foam.

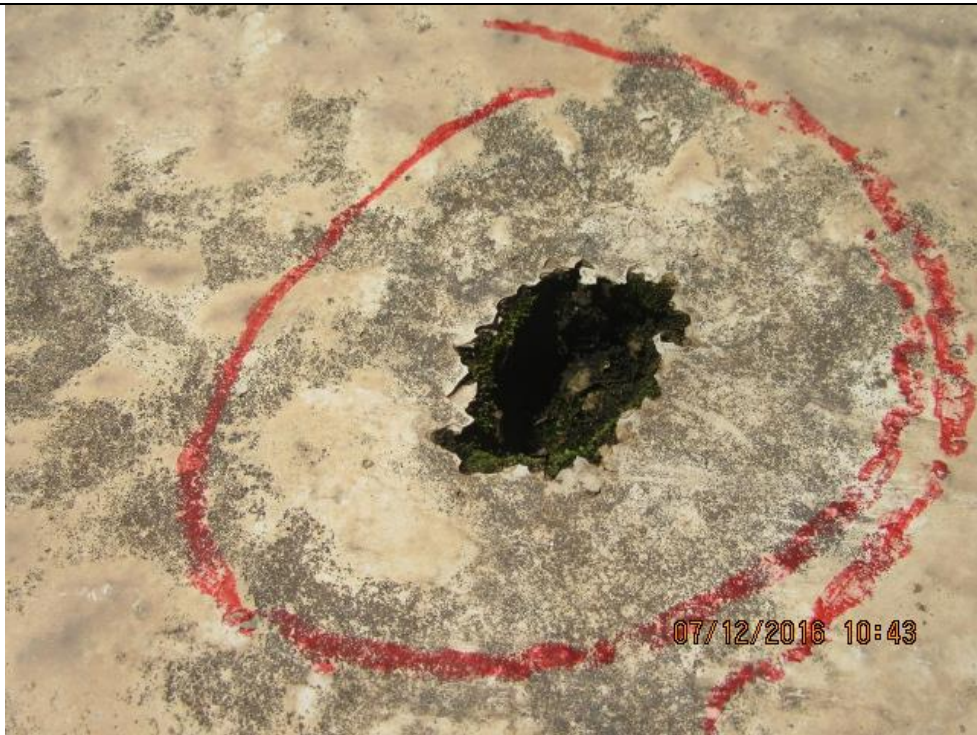
Photo # 27

Description: Roof #6, typical damage.

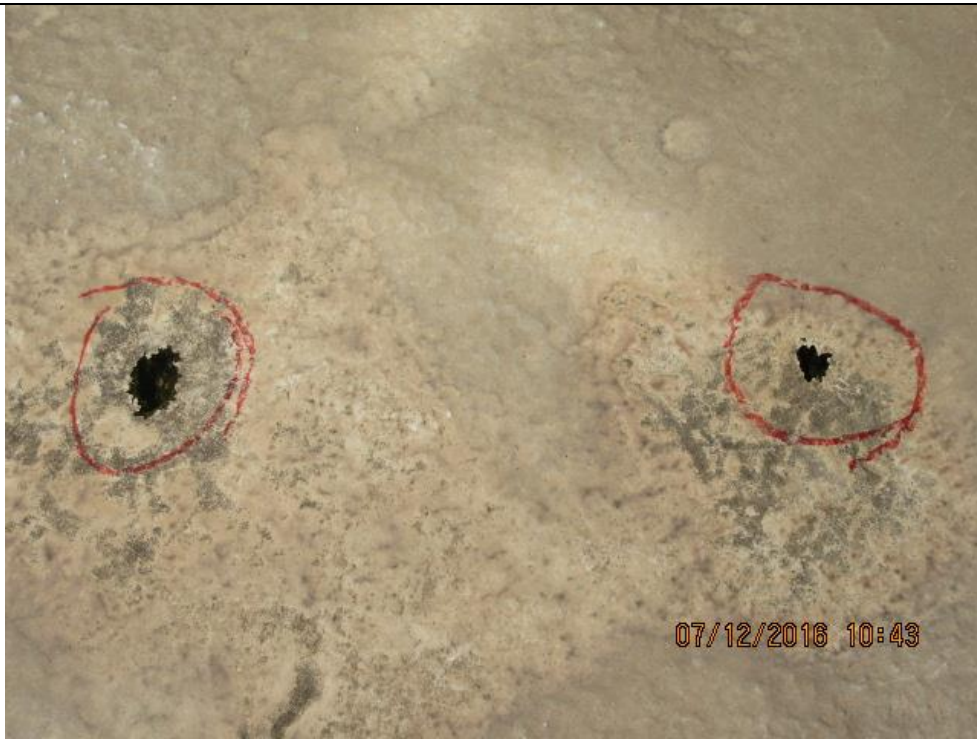
Photo # 28

Description: Roof #6, typical damage.

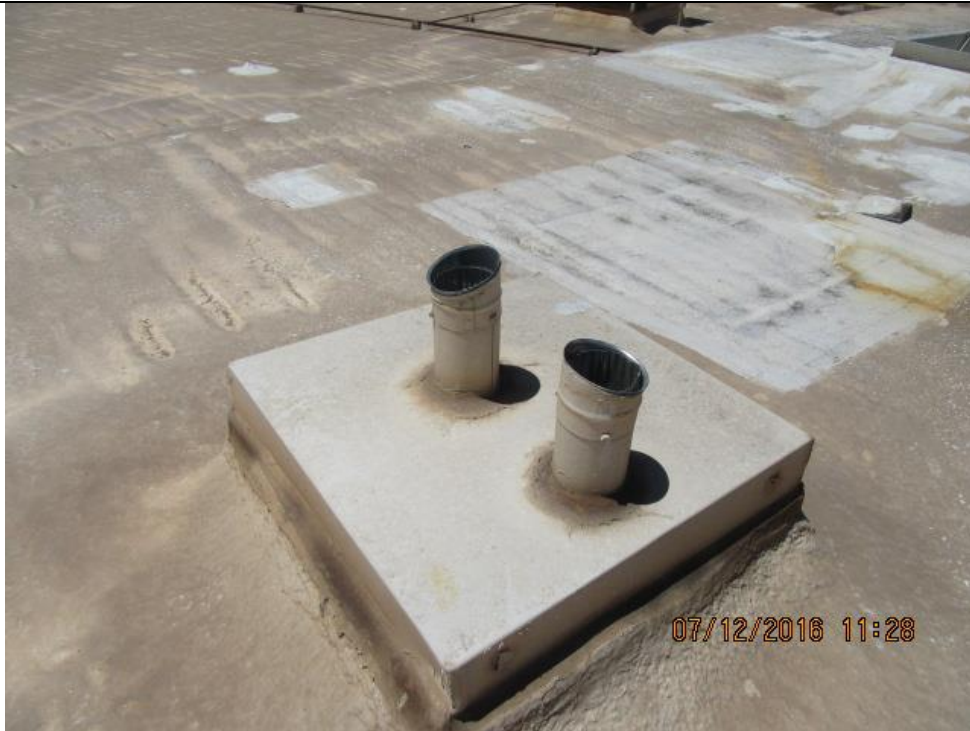
Photo # 29

Description: Roof #6, hoods missing off of vents, allowing water into building.

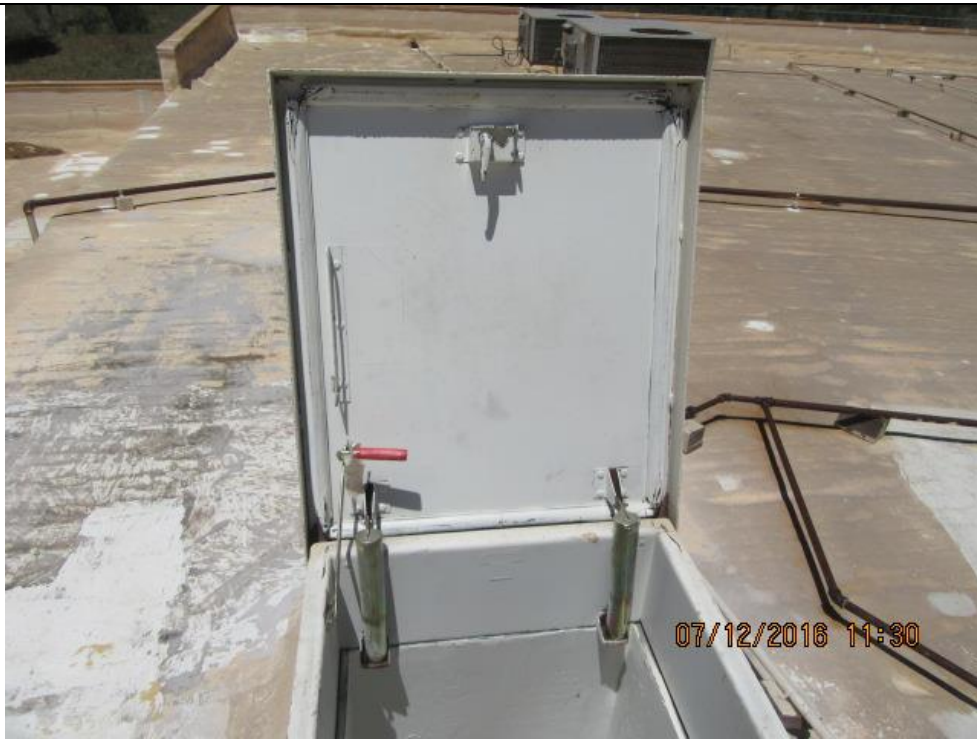
Photo # 30

Description: Roof #6, roof hatch mechanisms broken. New mechanisms needed.

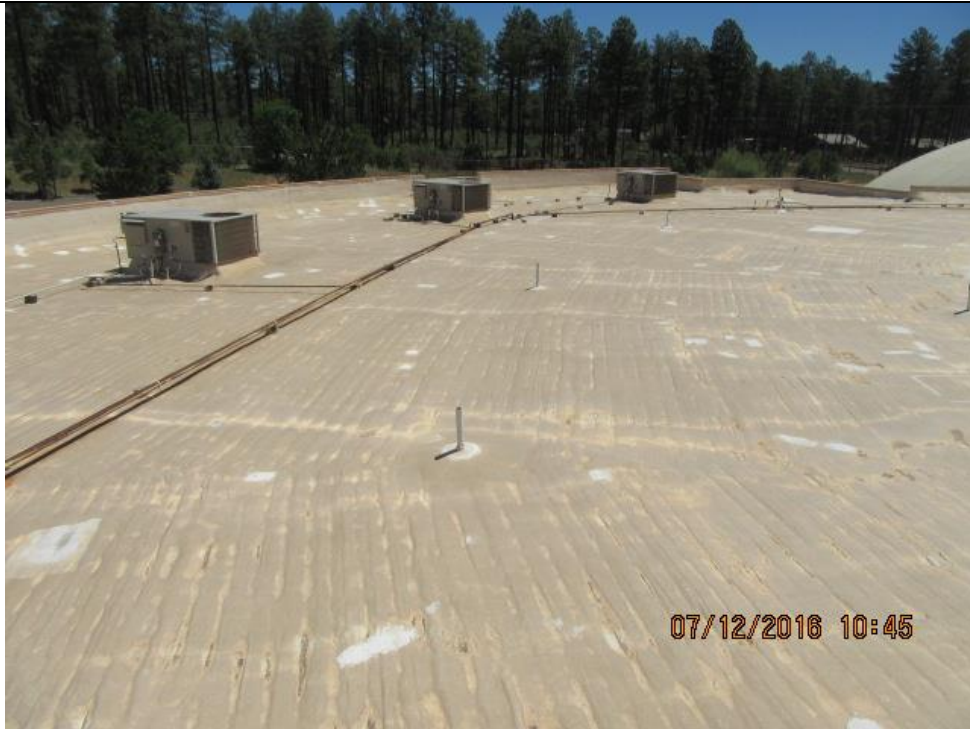
Photo # 31

Description: Roof #7, view of roof.
