Cradleboard Elementary School  
7301 Power Line Rd.  
Whiteriver, AZ 85941

Project: Roof Assessment

Inspection Date: 7/12/2016

Inspector: Jerry Brown, RRO & Bryan Hill, RRO

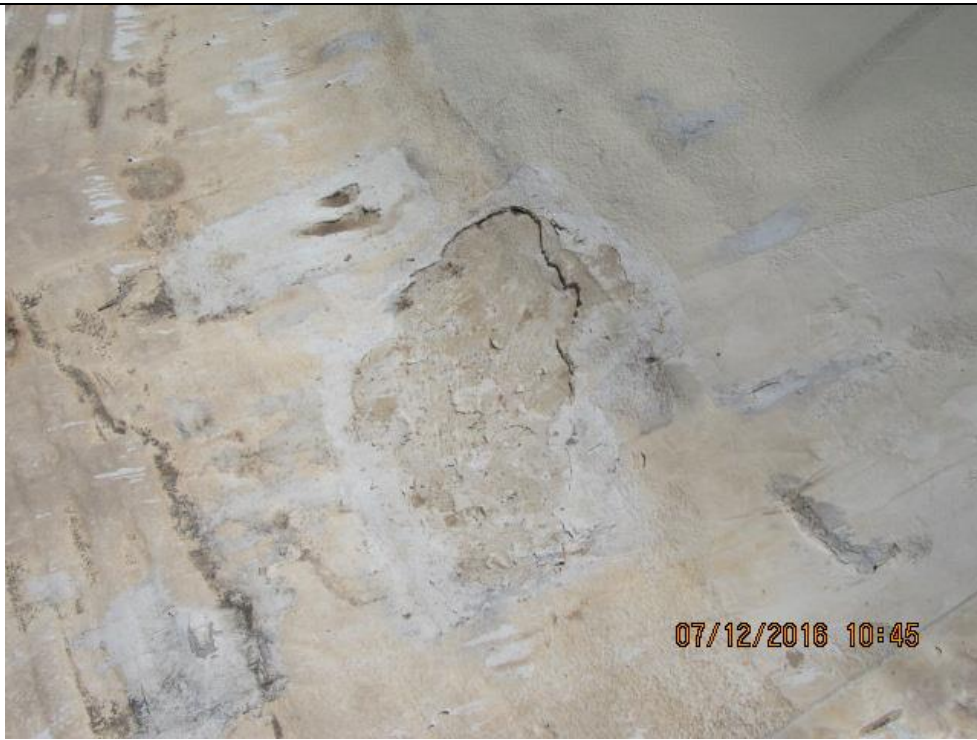
Photo # 32

Description: Roof #7, typical damage.

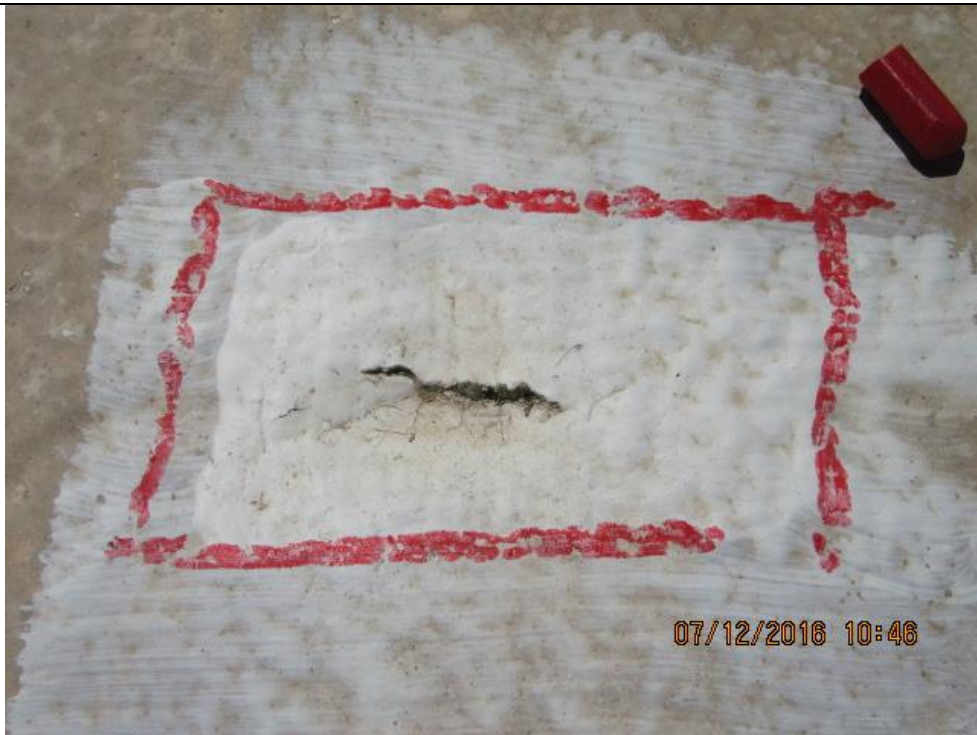
Photo # 33

Description: Roof #7, typical fractures that have been repaired multiple time and still failing.

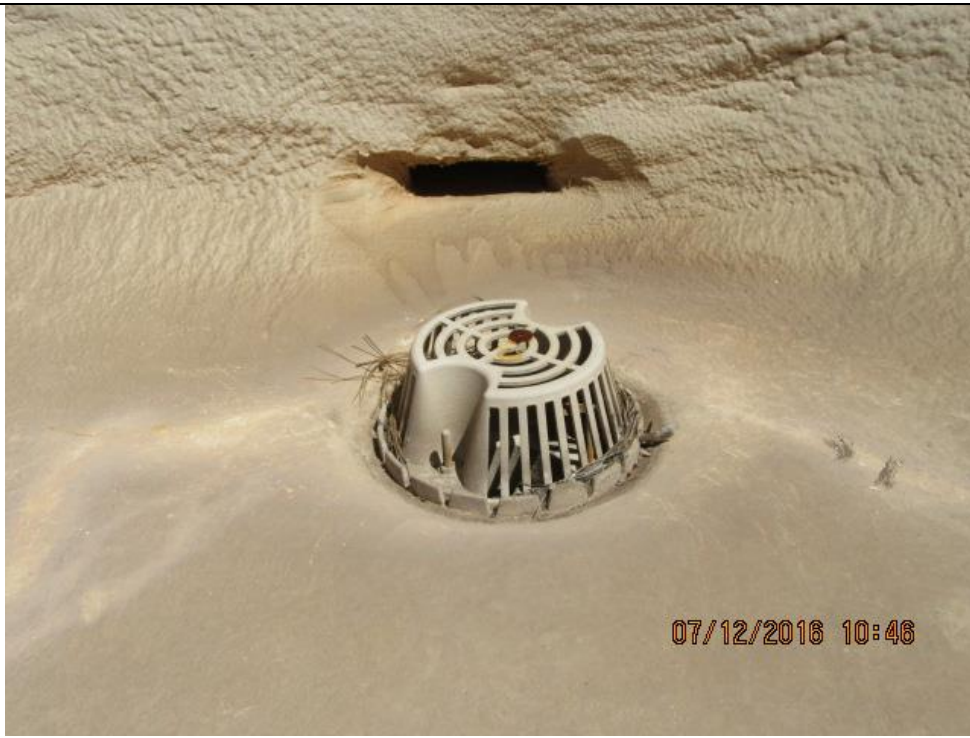
Photo # 34

Description: Roof #7, primary drain and overflow scupper.

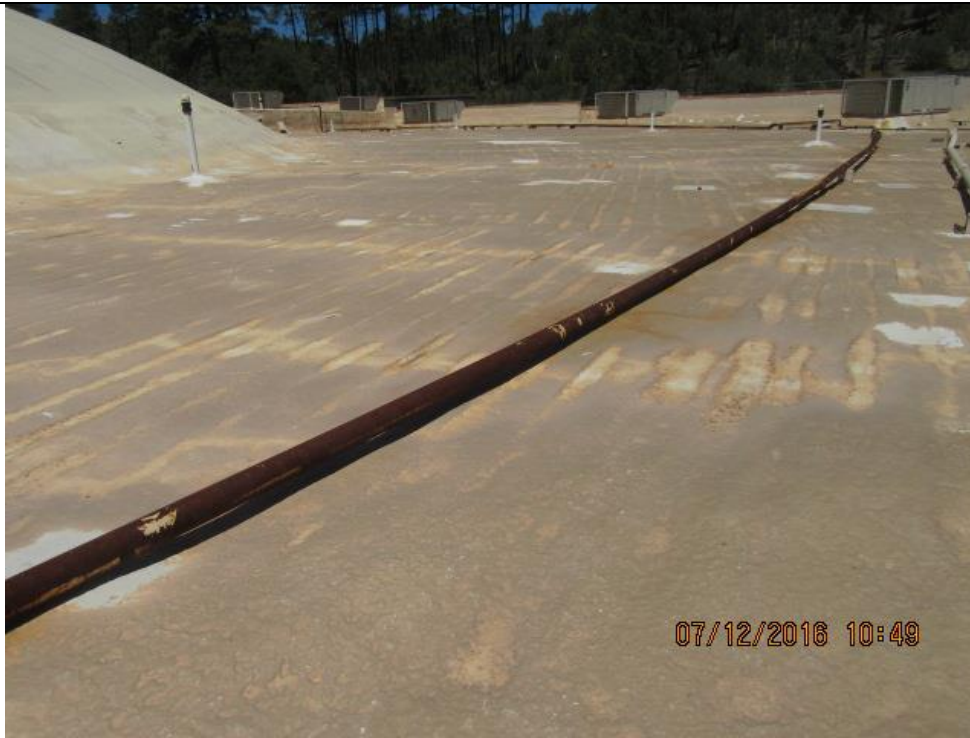
Photo # 35

Description: Roof #7, typical unsupported gas lines.
